# Village of Calumet 427 5th Street--Agnitz Block Structural Assessment

RE: 427 5<sup>th</sup> Street  
Structural Assessment Report

The inspection of 427 5th Street in the Village of Calumet has been completed. The initial drone inspection was conducted on June 7<sup>th</sup>, 2017 which included the roof and front façade. On August 3<sup>rd</sup> a second inspection was conducted which included the attic space, second floor, first floor, basement and exterior.

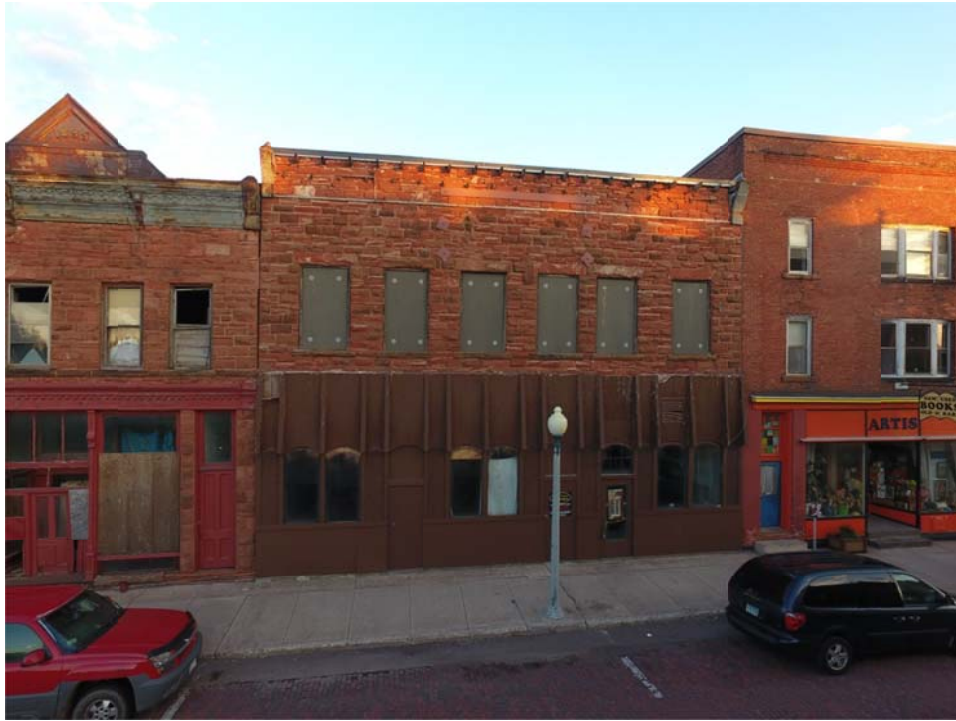
Figure 1—Drone view of the front facade.

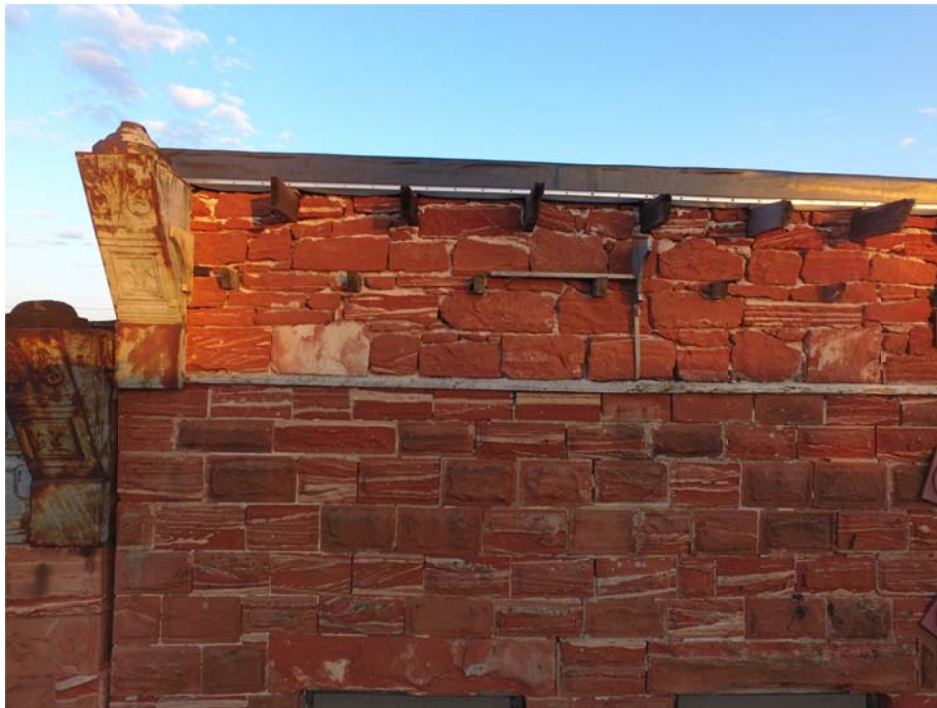
- The wood members protruding from the front façade are deteriorating.
- Portions of the upper sandstone on the front façade are in need of tuck-pointing.
- There is a section of brick missing on the South elevation in need of replacement.
- The front of the building has some wood cornice framing members which will continue to deteriorate over time and may allow moisture infiltration.

Figure 2—Drone view of the top of front façade showing wood cornice framing members.

1. Monitor the front wall and bracing system in place for any additional movement and reinforce if required.
2. Infill the brick gap on the South side to eliminate moisture access.
3. Protect wood cornice framing on the front façade to provide further deterioration.
4. Tuck-point the upper sandstone on front façade.
5. Reinforce and replace bearing wall framing along center wall.
6. Reinforce and replace floor framing in deteriorated areas of the first and second floors.
7. Replace back interior stairs.
8. Remove the rear shed.
9. Remove and reinforce any charred floor framing/decking.
10. Reinforce/replace beam support in the basement supporting the center bearing wall.
11. Prepare and paint basement structural steel supports to prevent further corrosion.

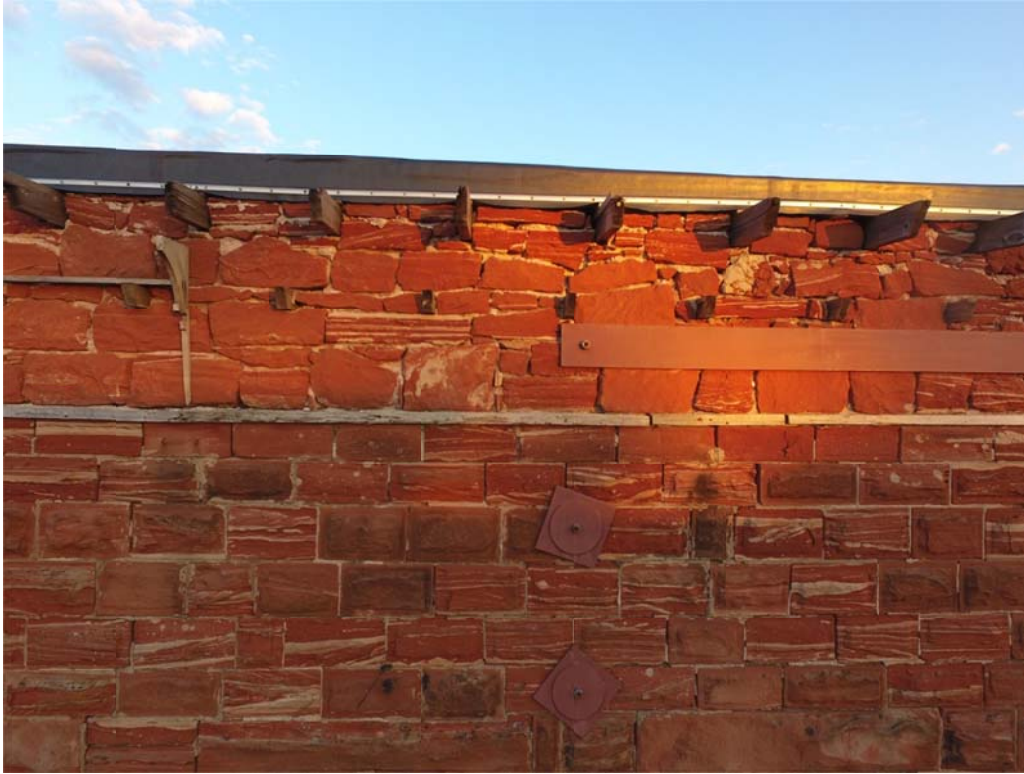
- There is a bracing system in place for the front wall which is attached to the roof structure.
- There is an area on the South side of the building with a gap at the top which can allow moisture infiltration and/or pigeon access.

Figure 3—Drone view of the front façade with bracing plates visible.

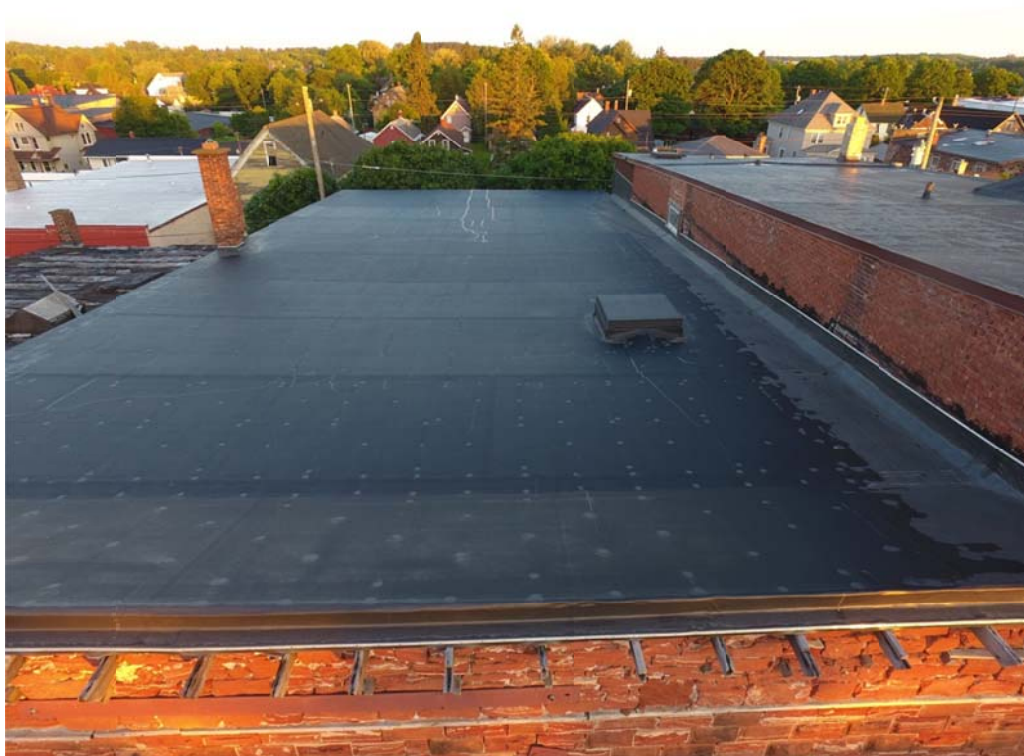
Figure 4—Drone view of the South side roof and top of façade.

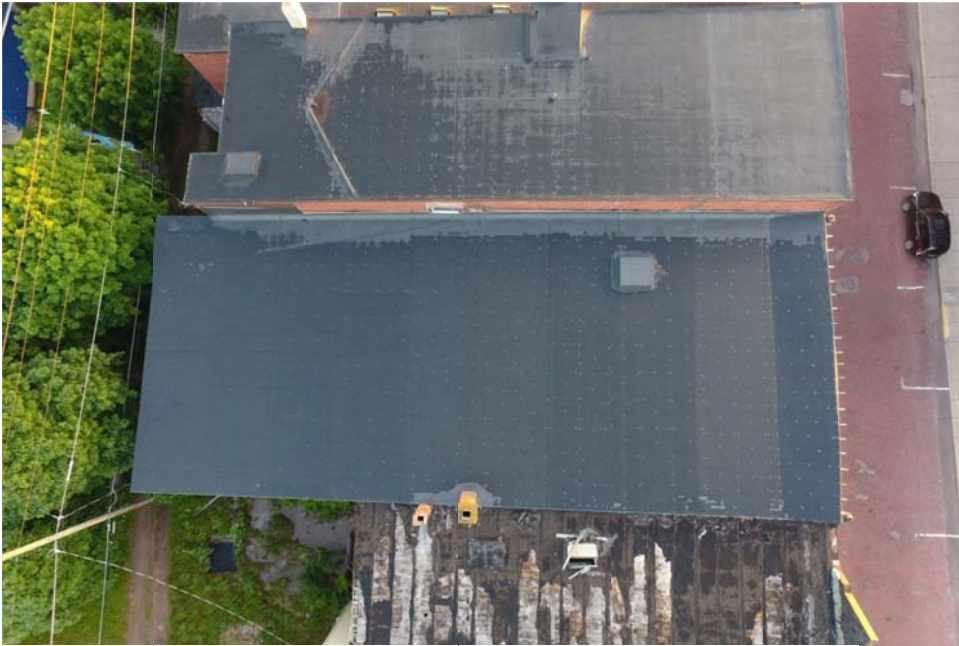
Figure 5—Drone view of the roof.

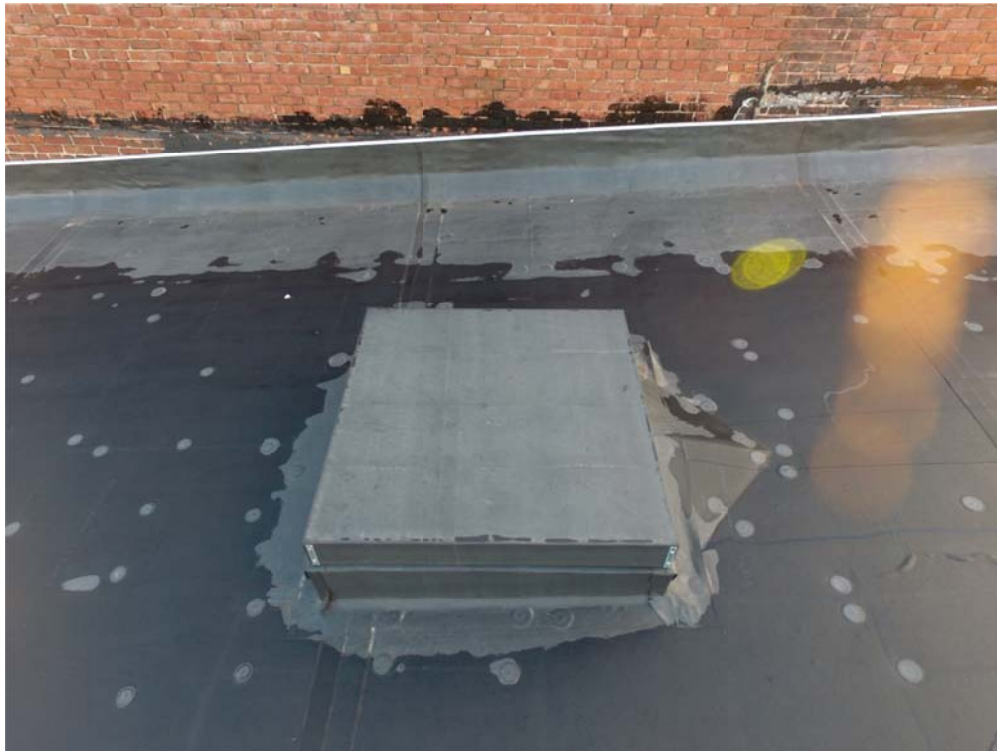
Figure 6—Drone close up view of the roof hatch and flashing at wall/roof line.

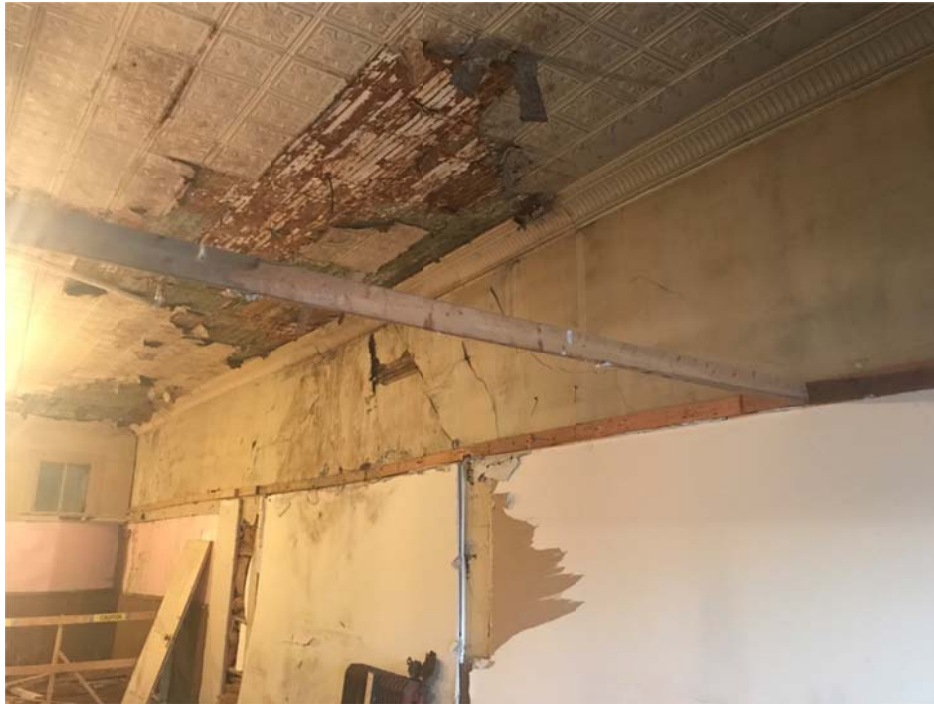
- Moisture damage is evident in the ceiling near the center bearing wall.
- Temporary supports are in place for the second level framing due to rotting.
- Portions of the first level are barricade due to unstable framing.
- The bearing wall in the center of the building has settled.
- Some of the floor boards have buckled.

Figure 7—Ceiling moisture damage view from the first floor.

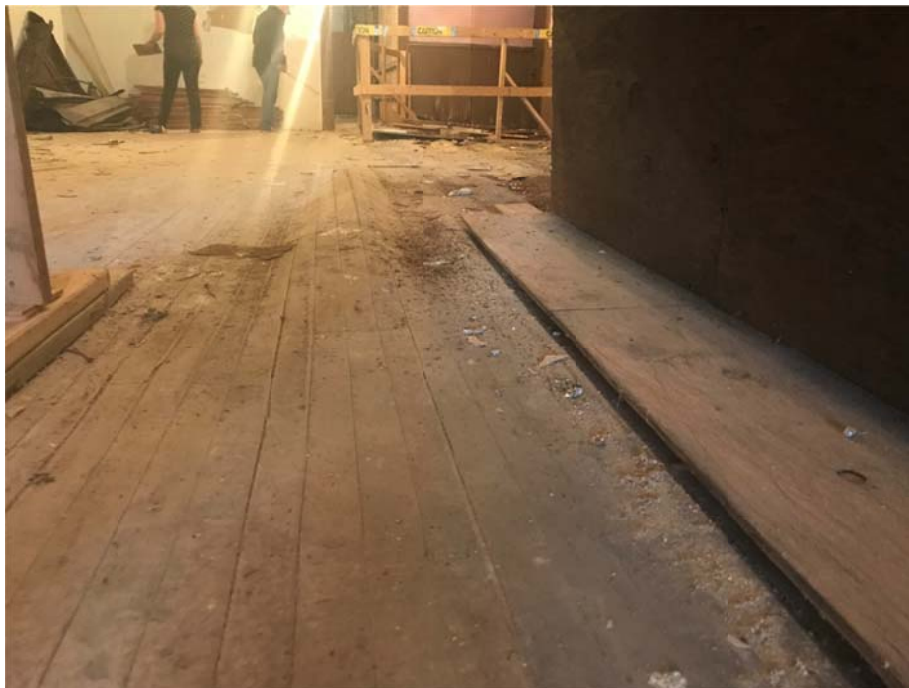
Figure 8—View of buckled wood flooring on first level.

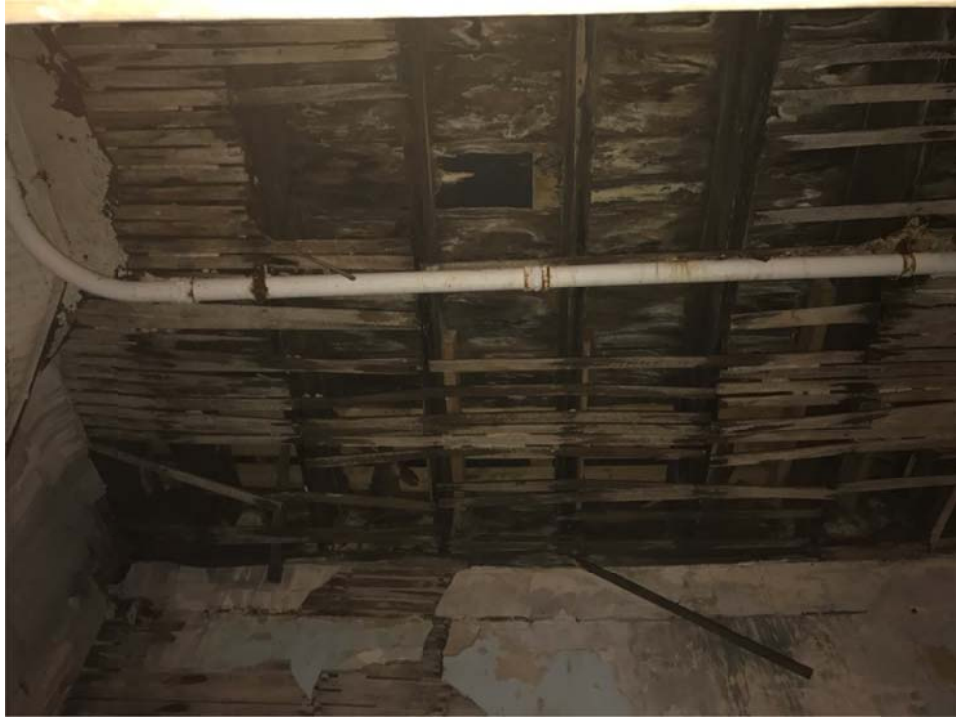
Figure 9—View of ceiling moisture damage from the first level.

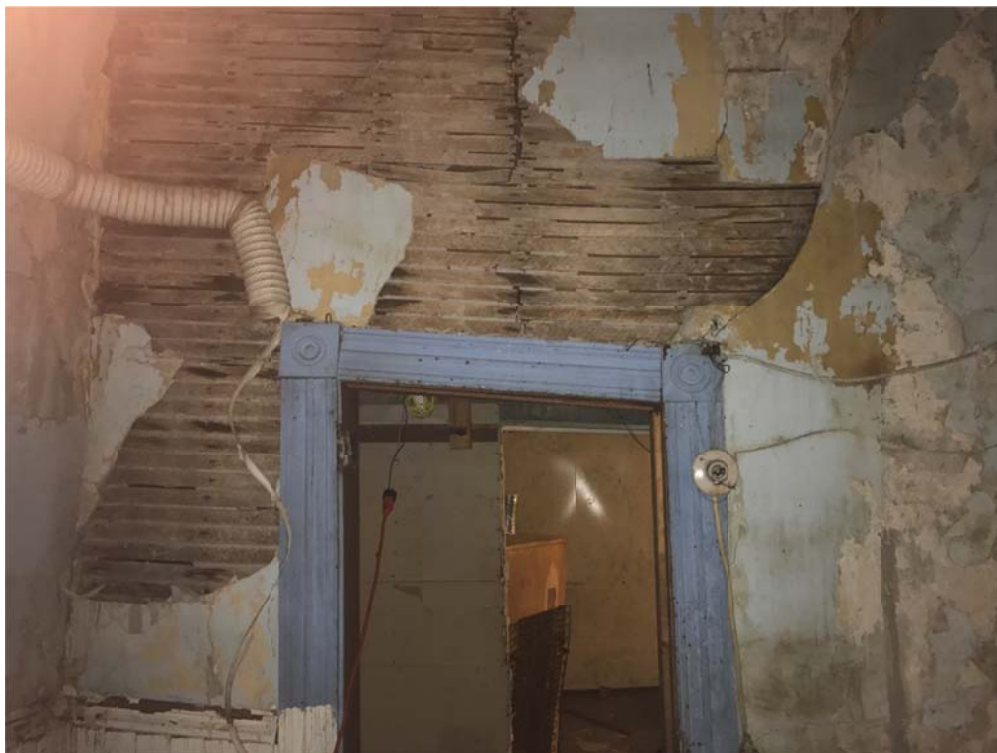
Figure 10—View of interior bearing wall which has settled.

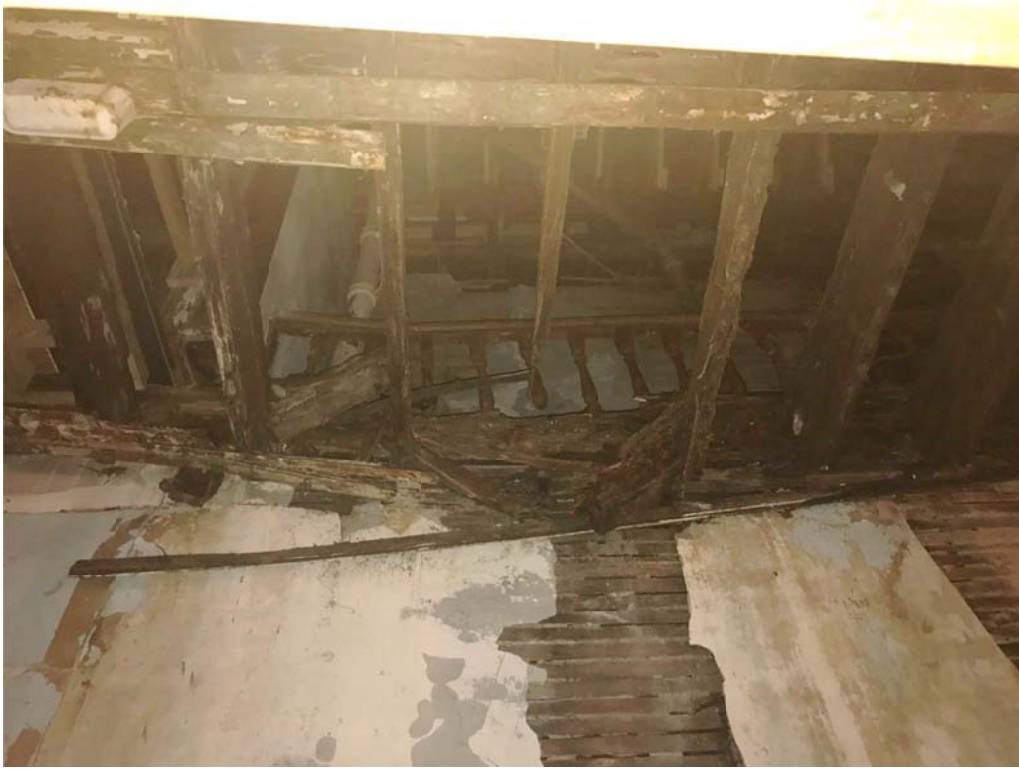
Figure 11—View of rotted second floor framing.

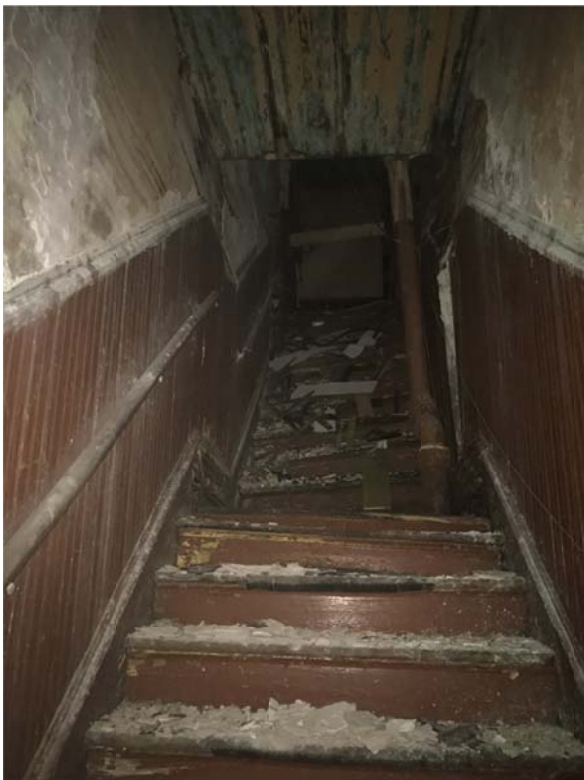
Figure 12—View of impassable rear stairs due to moisture damage.

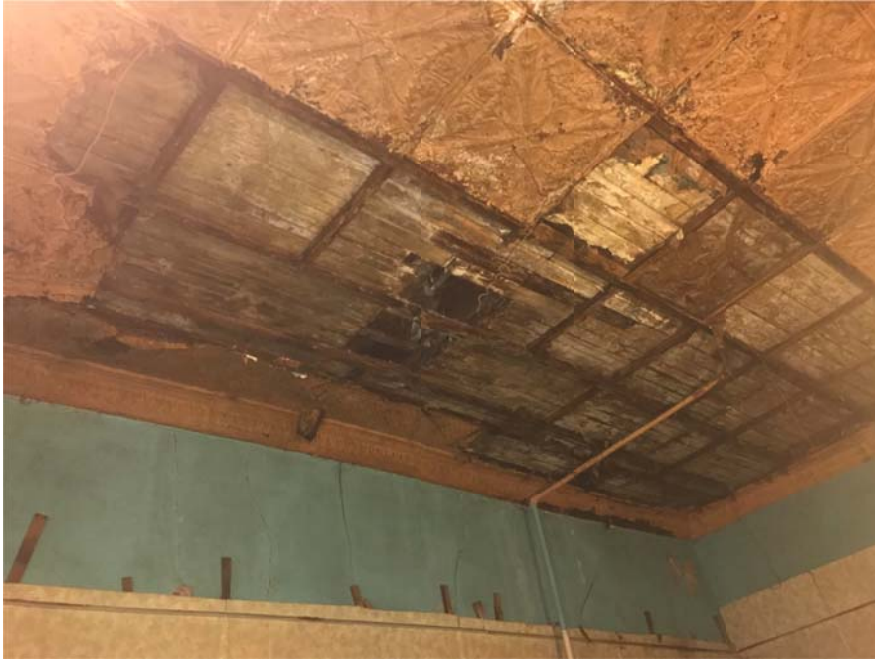
Figure 13—View of moisture damage at the first floor ceiling.

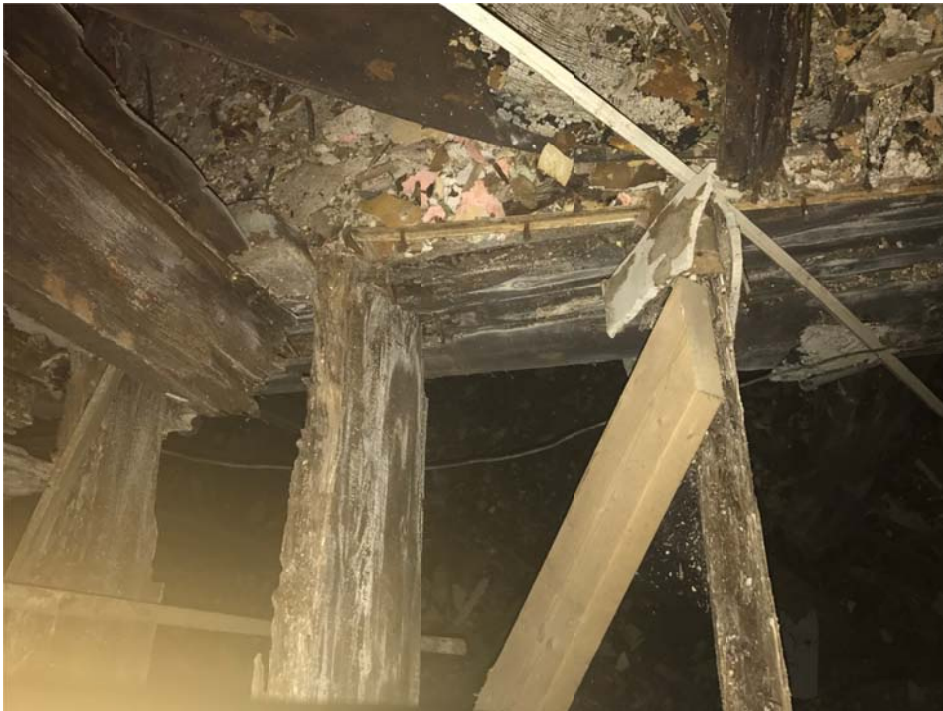
Figure 14—View of rotted second floor framing.

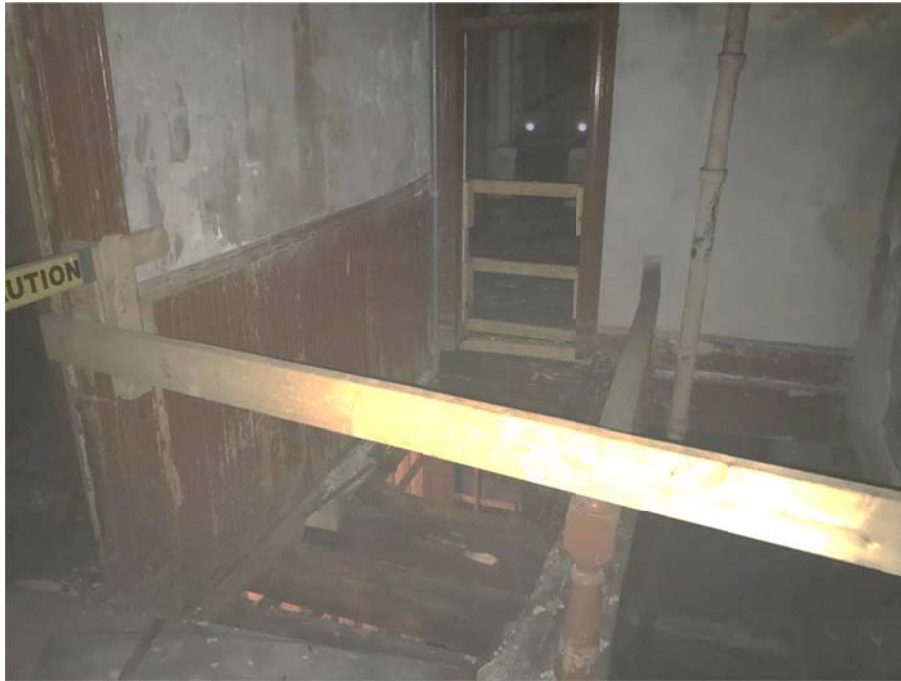
Figure 15—View of barricade areas of the second floor due to rotted floor framing.

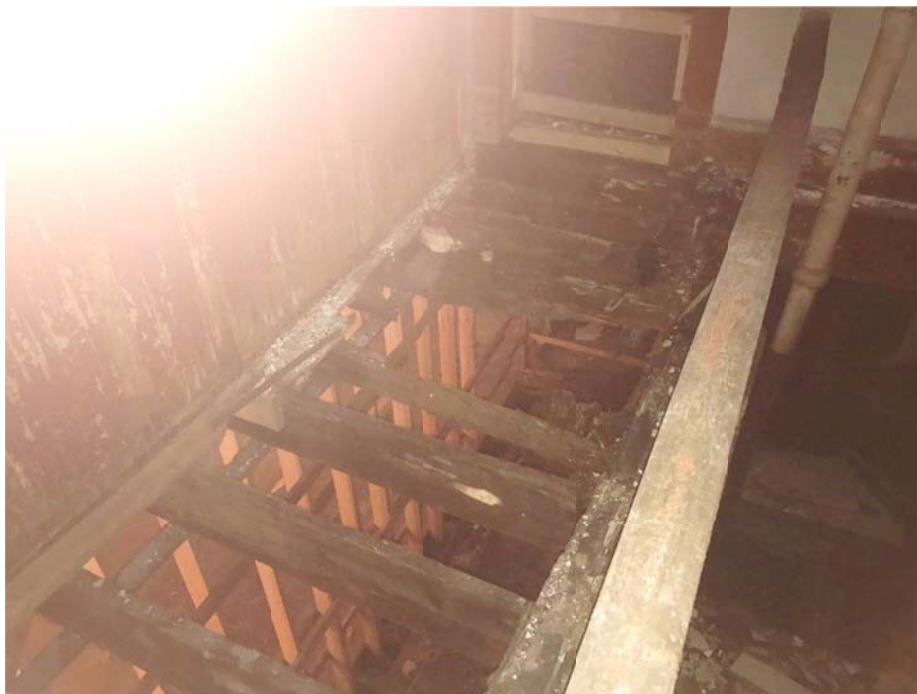
Figure 16—Close up view of moisture damage at the second level.

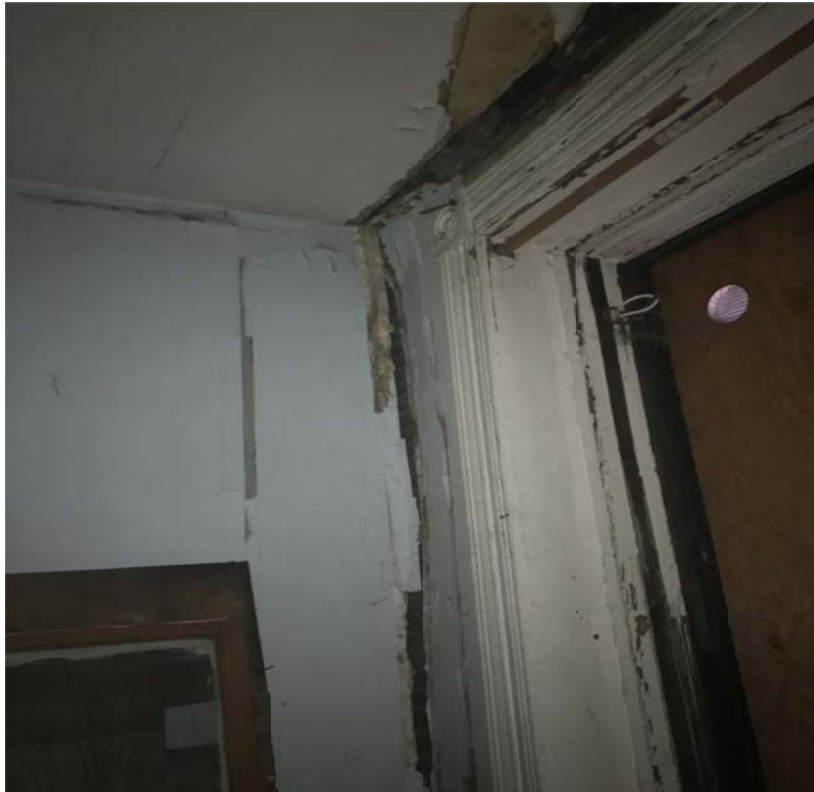
Figure 17—View of gap in corner at the front wall at the second level.

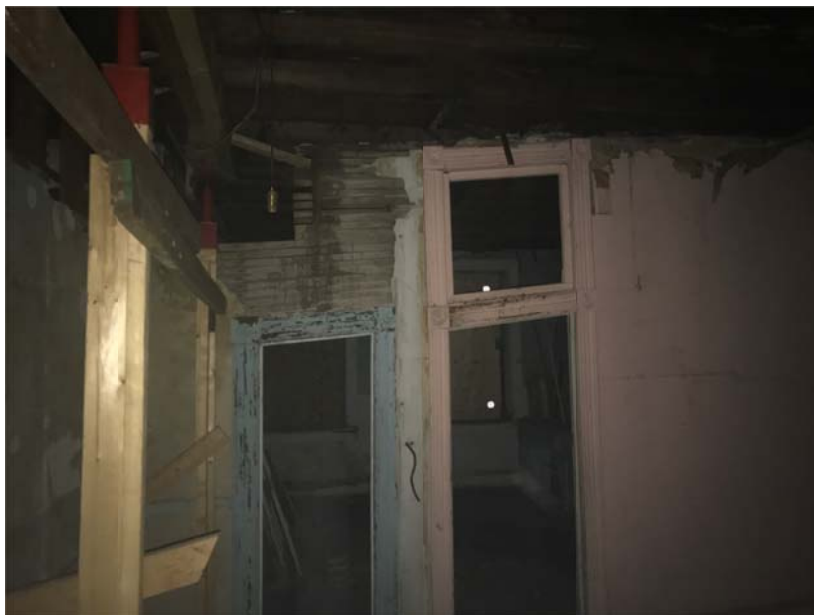
Figure 18—View of deflected interior bearing wall at the second level.

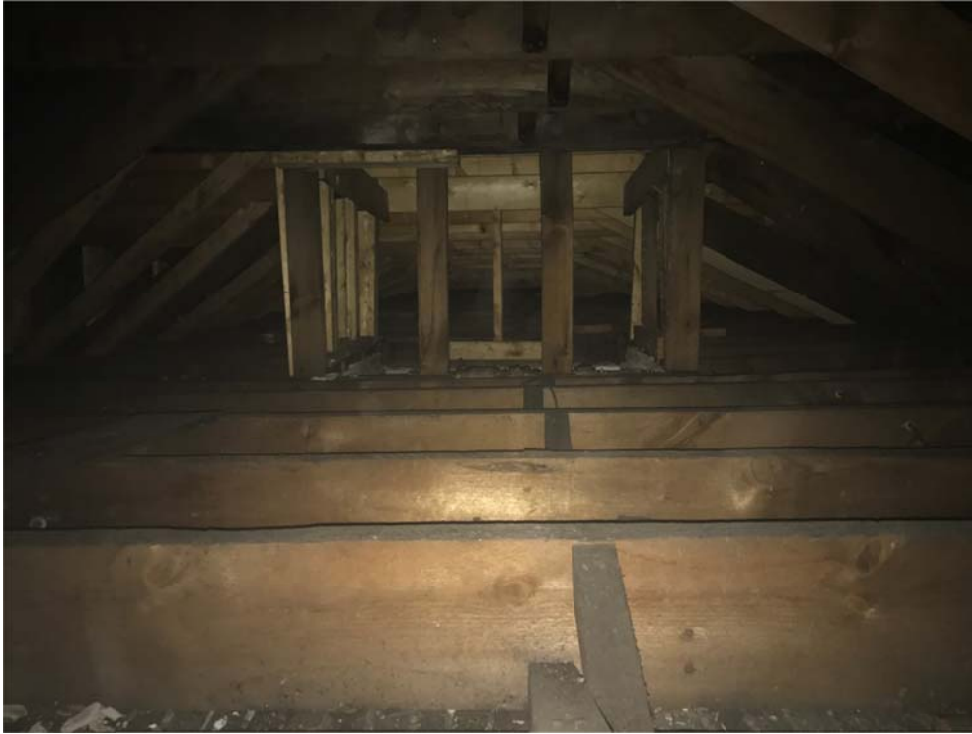
Figure 19—View in the attic of the roof framing.

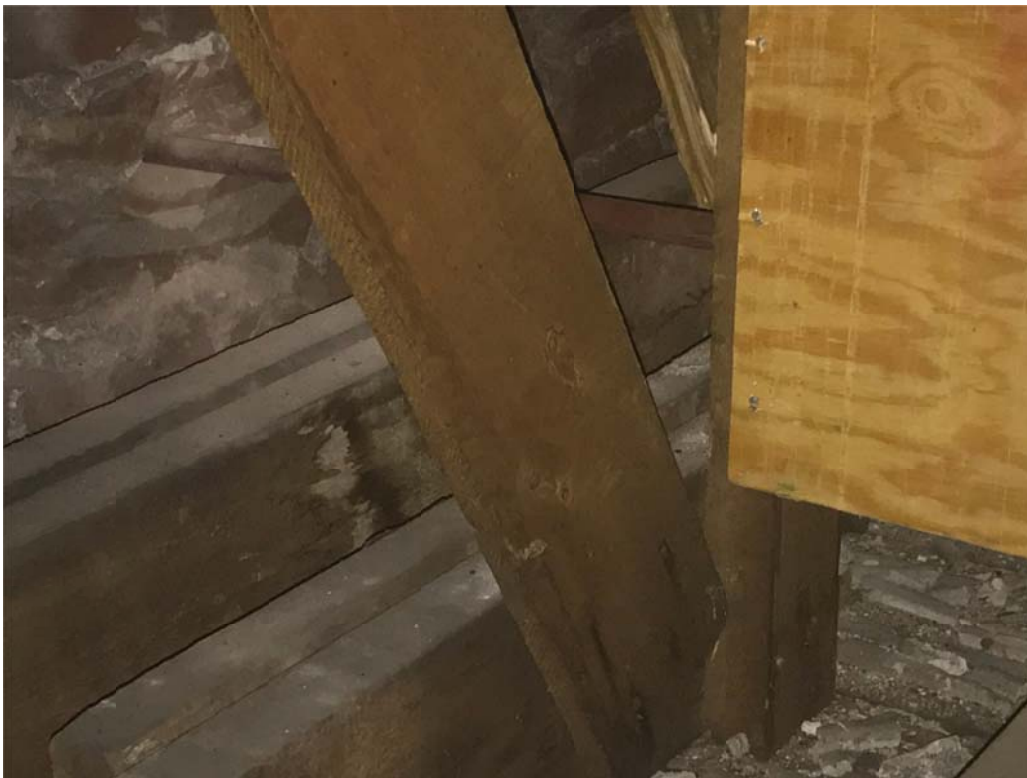
Figure 20—View in the attic of the bracing of the front wall to the roof structure.

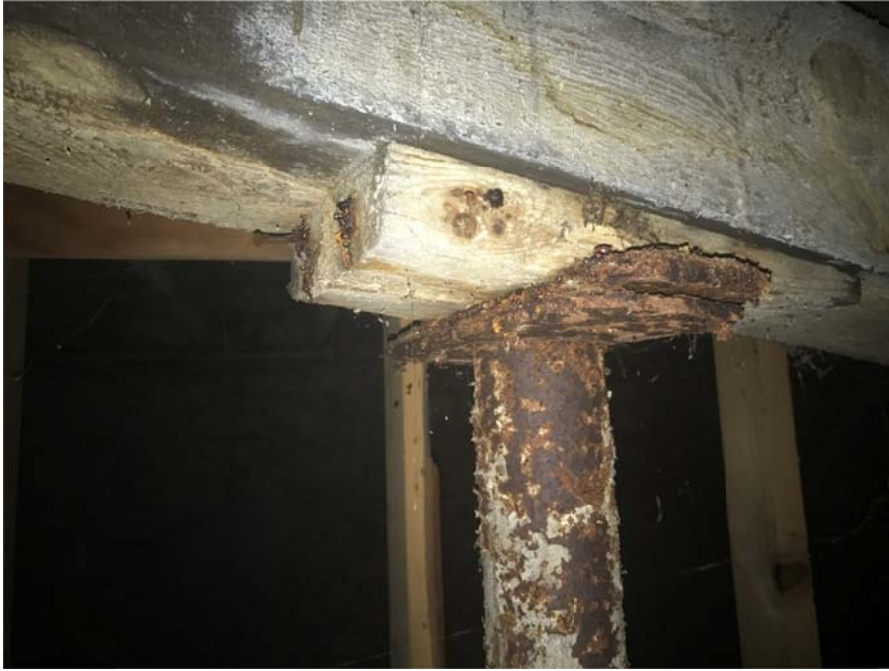
Figure 21—View of in basement of steel framing corrosion.

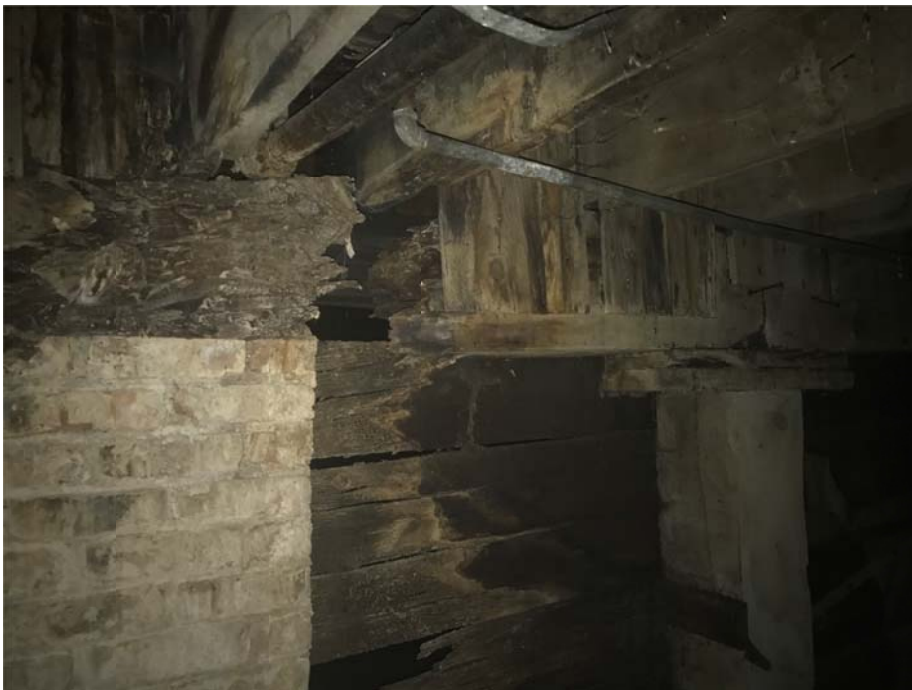
Figure 22—View of rotted support beam in basement.

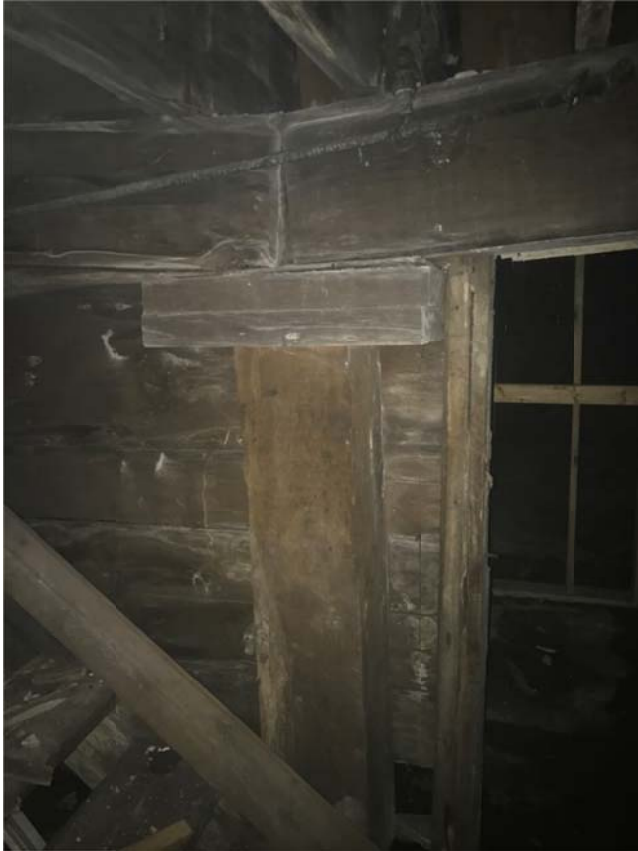
Figure 23—View of settlement of support in the basement.

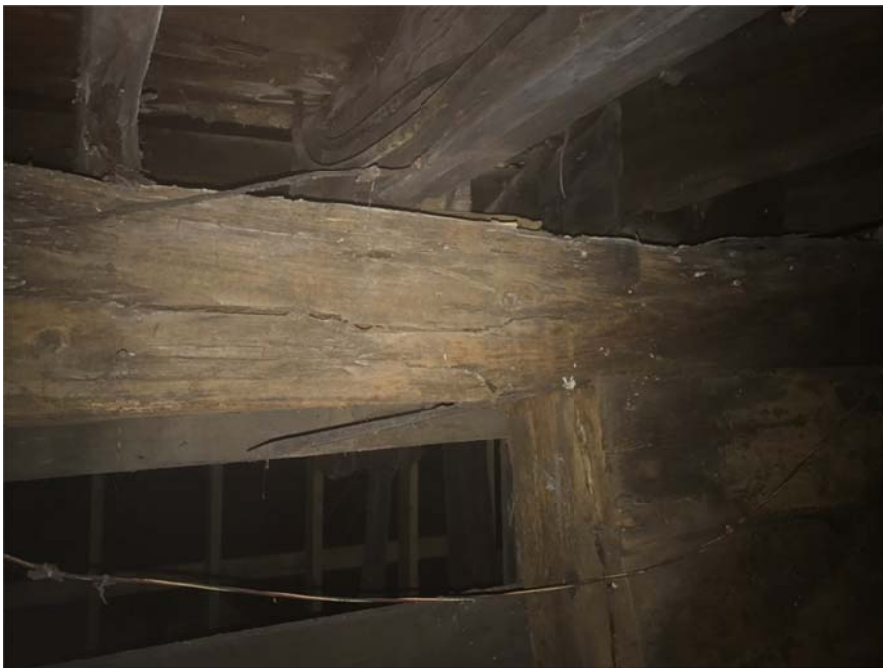
Figure 24—View of wood beams need of reinforcement/replacement.

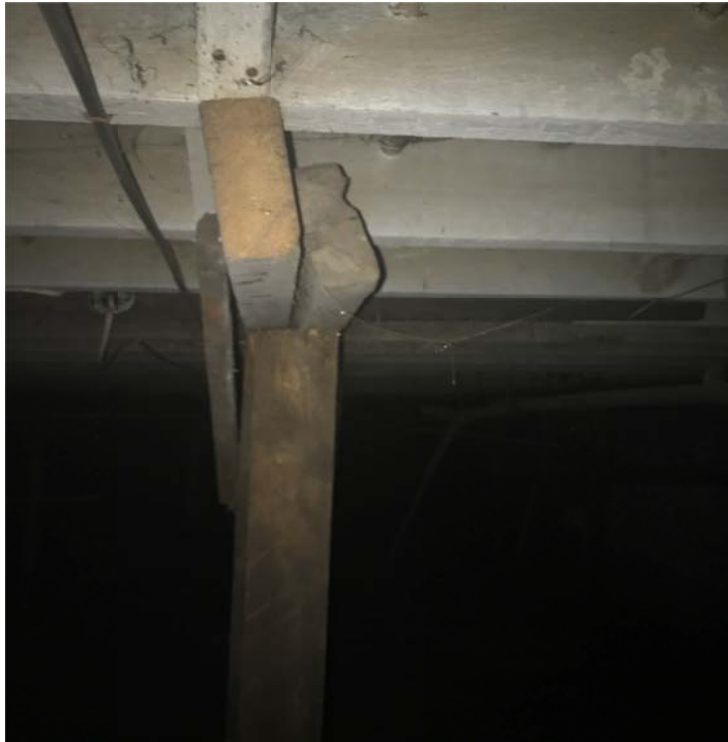
Figure 25—View of leaning beams basement.

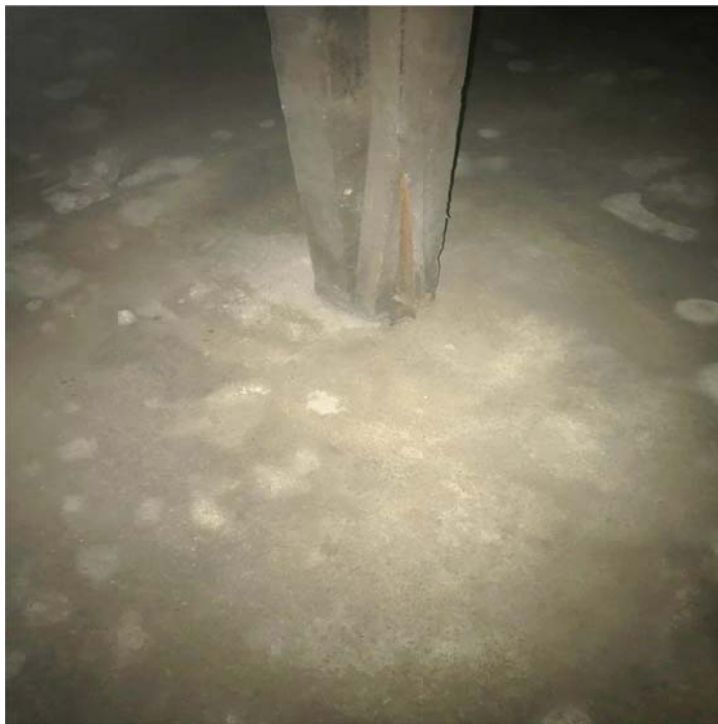
Figure 26—View of wood column base which has cracked in the basement.

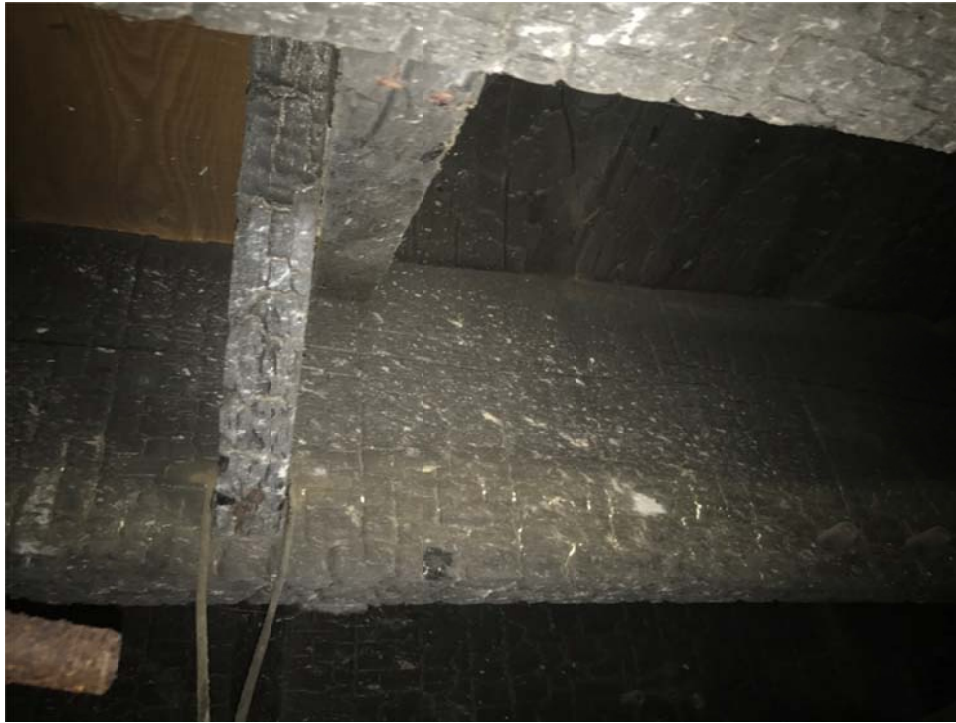
Figure 27—View of charred first floor framing.

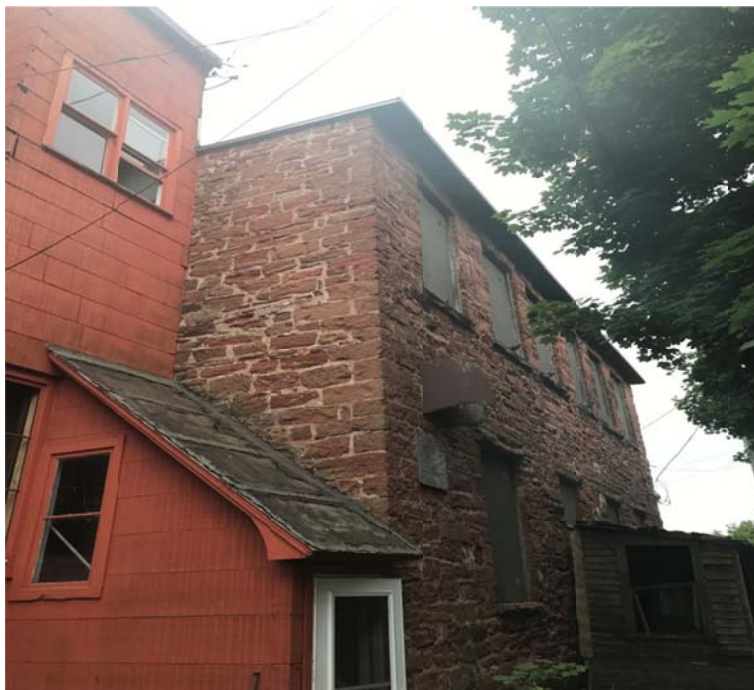
Figure 28—View of the rear building exterior.

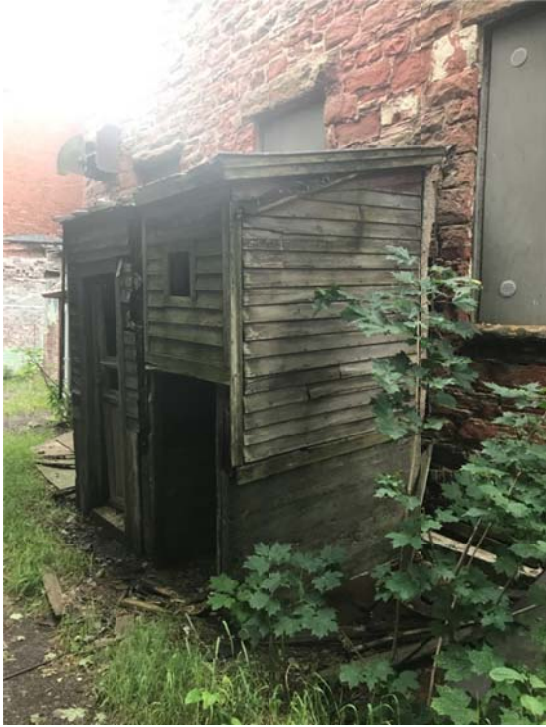
Figure 29—View of dilapidated shed at the rear of the building.

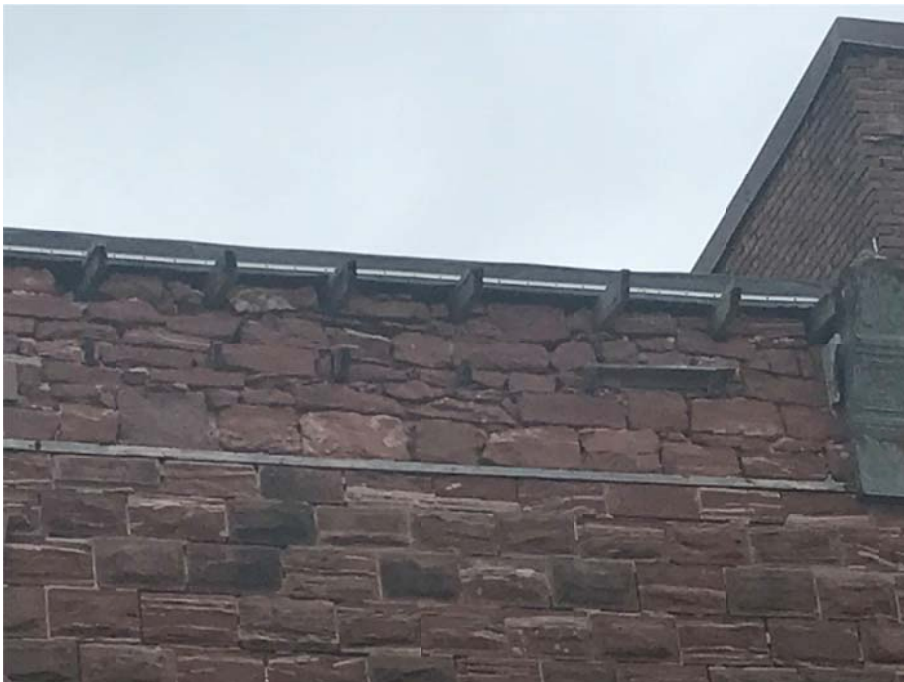
Figure 30—View of top of front façade with deteriorated masonry joints visible.

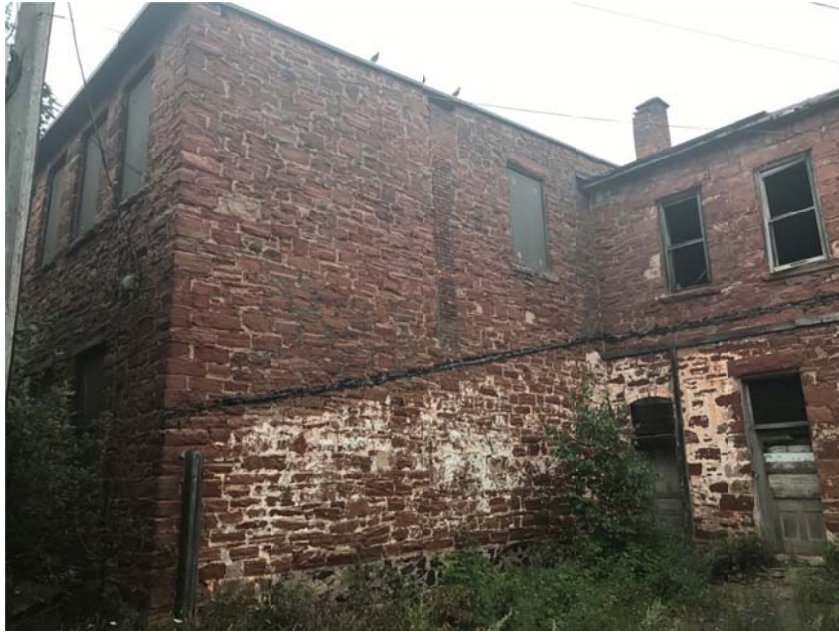
Figure 31—View of the South elevation of the building.

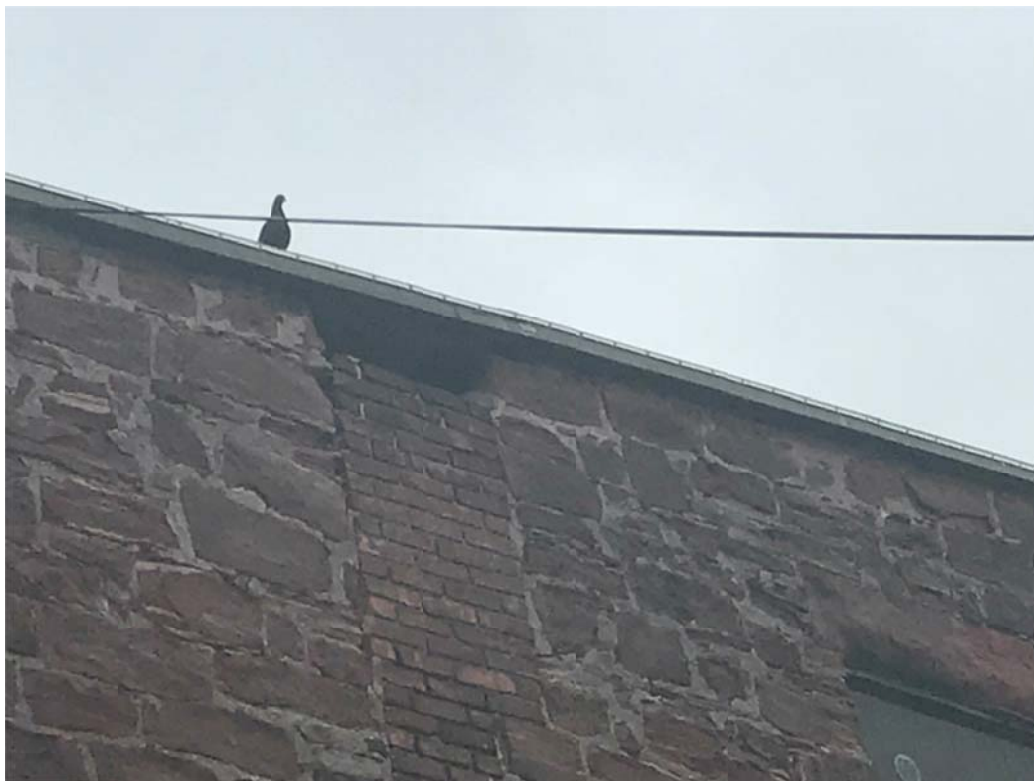
Figure 32—View of brick gap at the top of the South elevation.
