# Village of Calumet 427 5th Street--Agnitz Block Structural Assessment

RE: 427 5<sup>th</sup> Street  
Structural Assessment Report

The inspection of 427 5th Street in the Village of Calumet has been completed. The initial drone inspection was conducted on June 7<sup>th</sup>, 2017 which included the roof and front façade. On August 3<sup>rd</sup> a second inspection was conducted which included the attic space, second floor, first floor, basement and exterior.

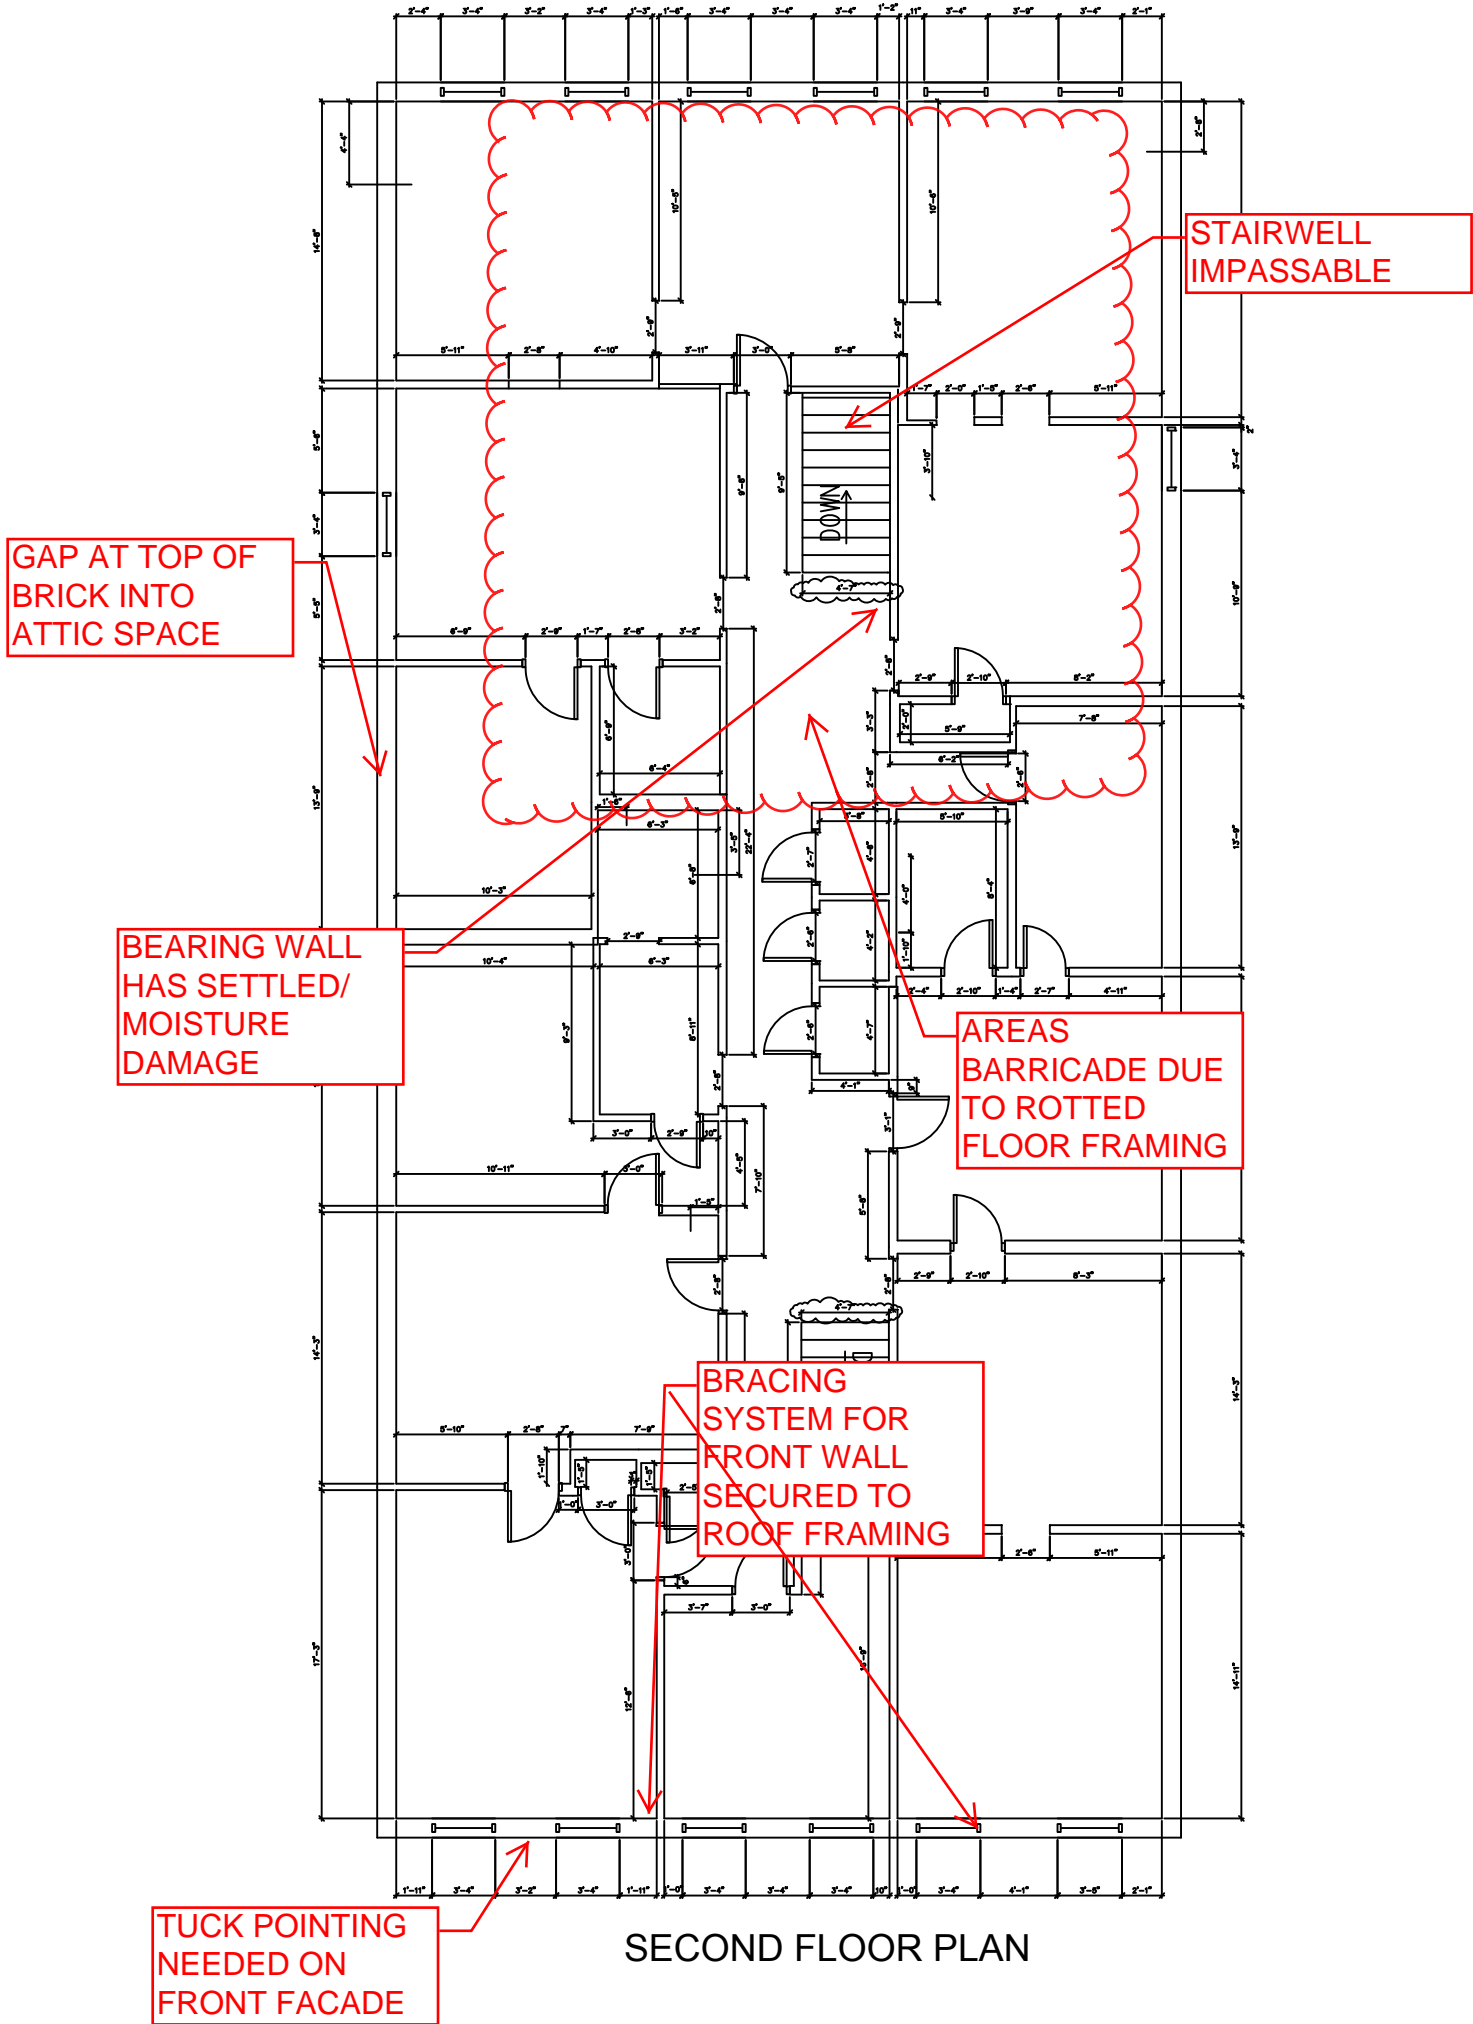
SECOND FLOOR PLAN

FLOOR BOARDS  
BUCKLED

AREAS  
BARRICADED.  
SETTLEMENT OF  
BEARING WALL  
MOISTURE  
DETERIORATION  
THROUGHOUT

STAIRWELL  
IMPASSABLE  
AND UNSOUND

CEILING  
MOISTURE  
STAINING
