# Village of Calumet 512 Portland Street—Curto Building Structural Assessment

October 18, 2017

RE: 512 Portland Street  
Structural Assessment Report

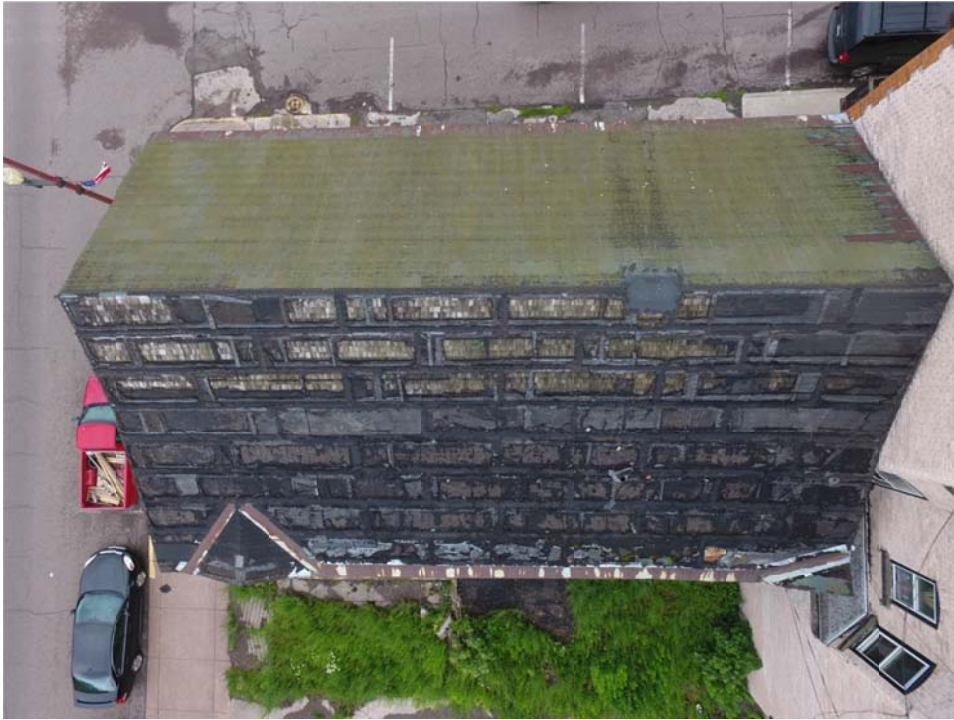
Figure 1—Drone view of the existing roof.

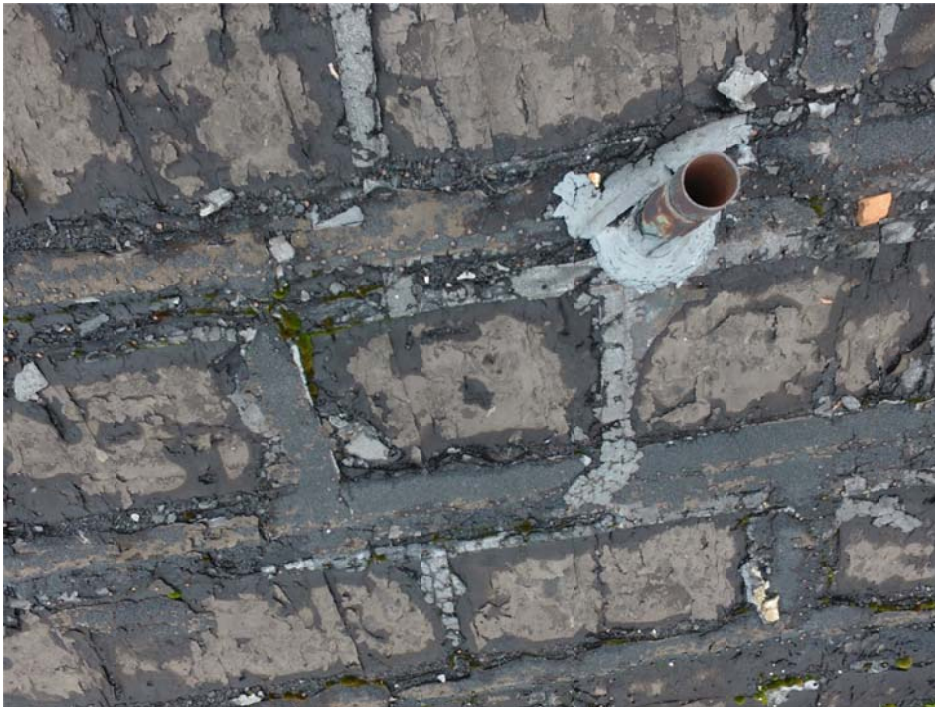
Figure 2—Drone close up view of the roofing and existing vent

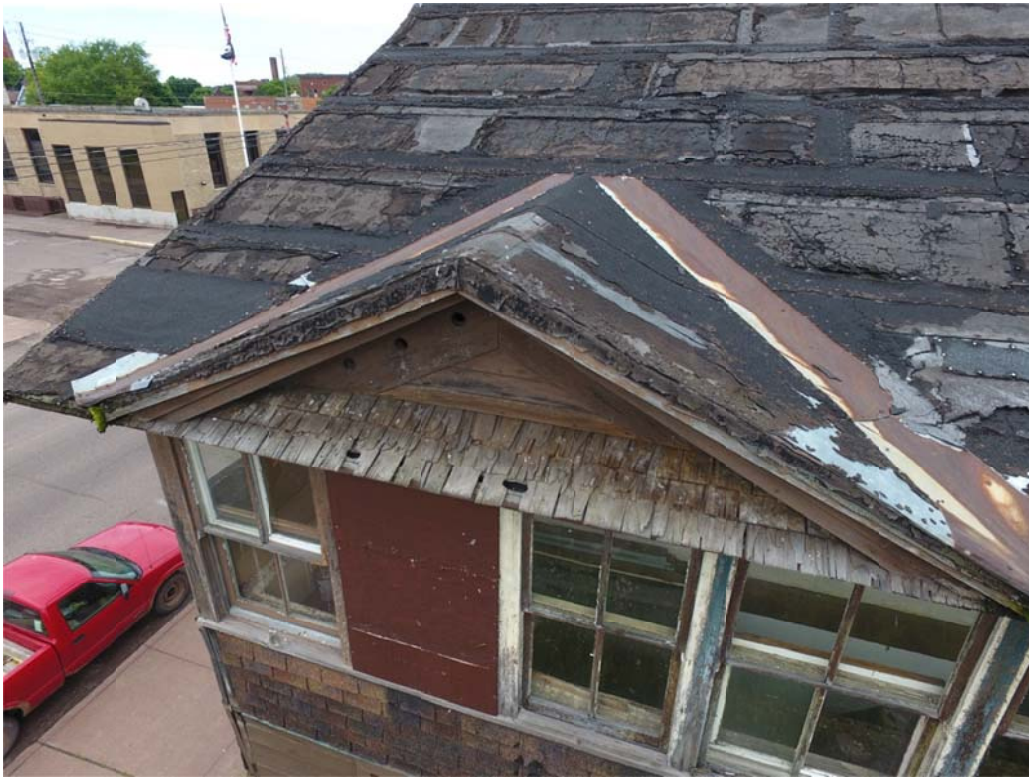
Figure 3—Drone view of dormer--note severe condition of roof.

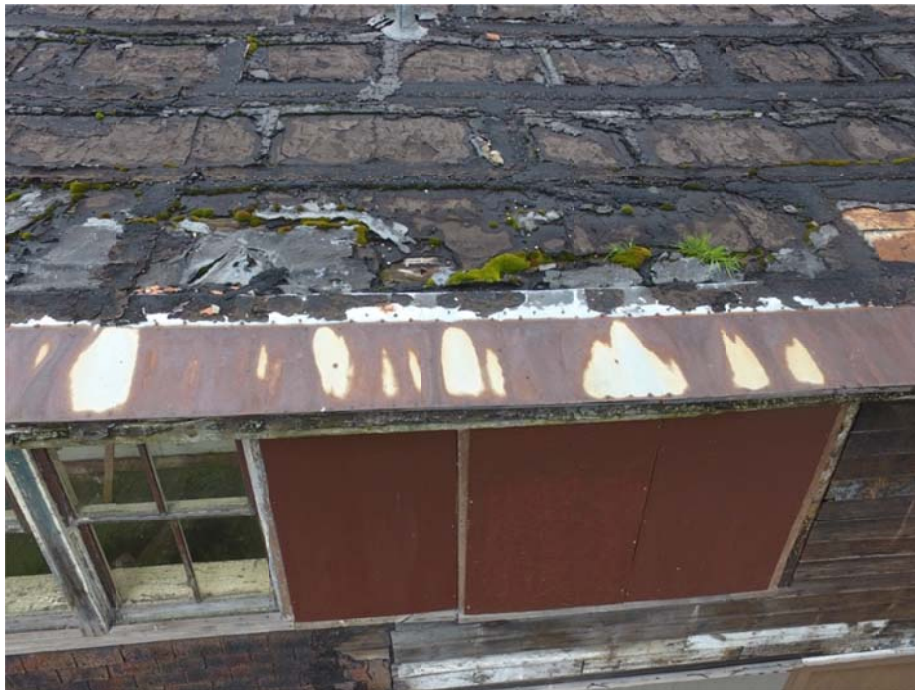
Figure 4—Drone view of eave with moss and deterioration visible.

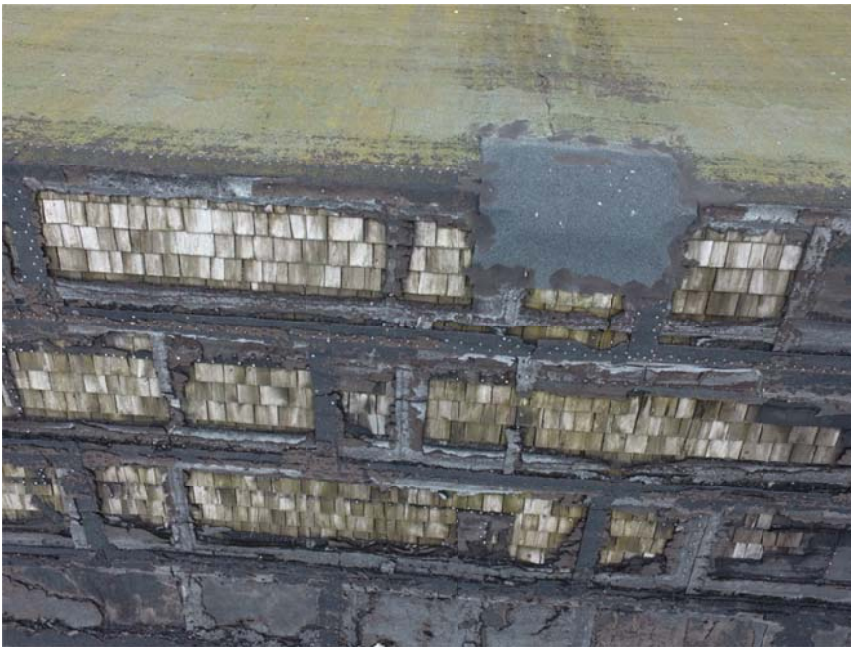
Figure 5—Drone view of chimney patch.

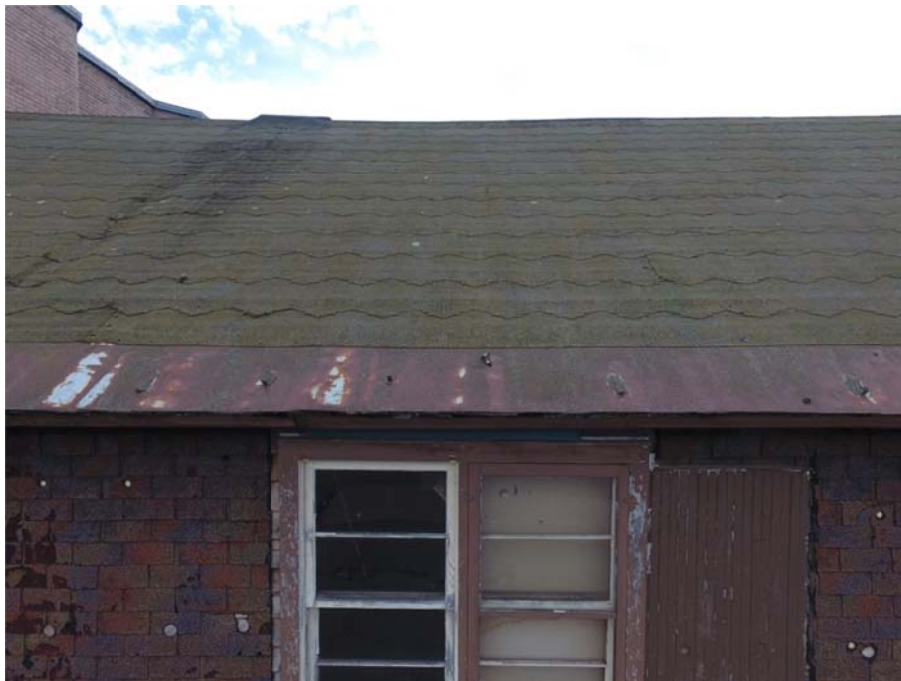
Figure 6—Drone view of North roof note sag in roof from chimney patch to eave.

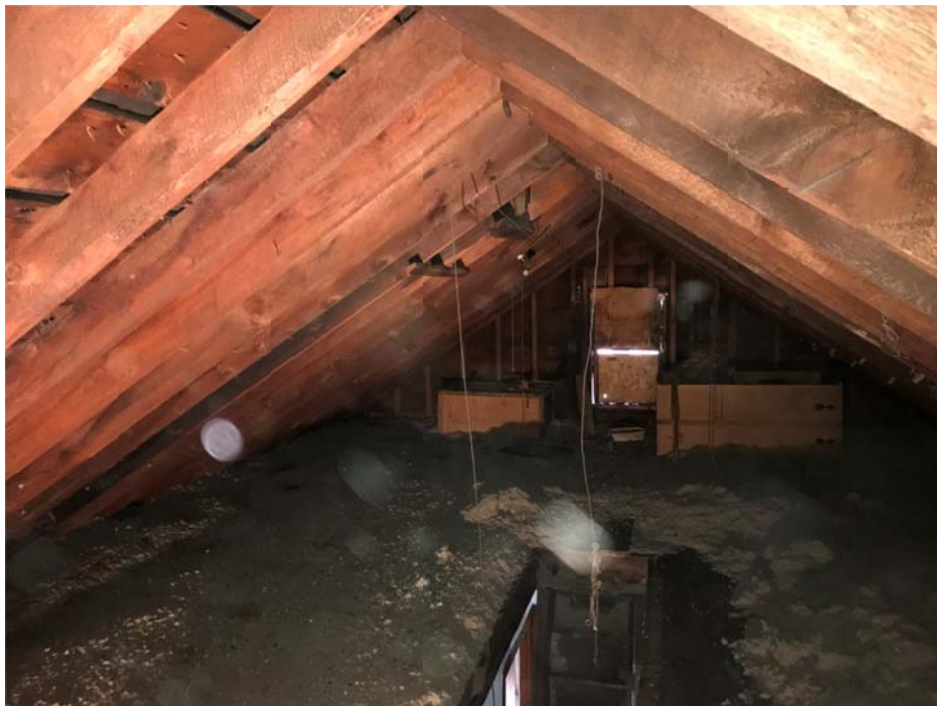
Figure 7—View of roof framing in attic looking West.

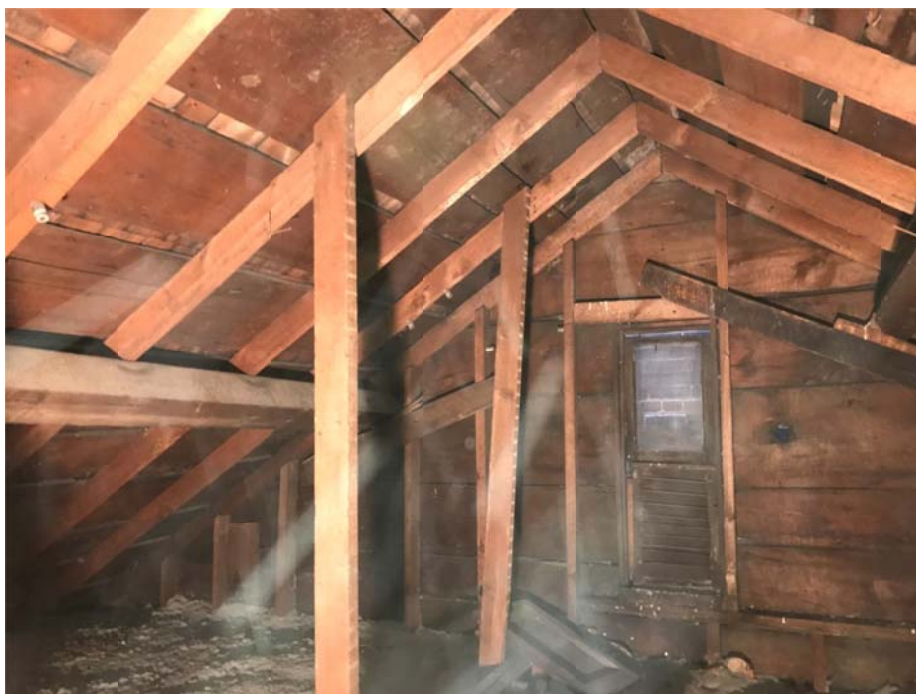
Figure 8—View of roof framing in attic looking East.

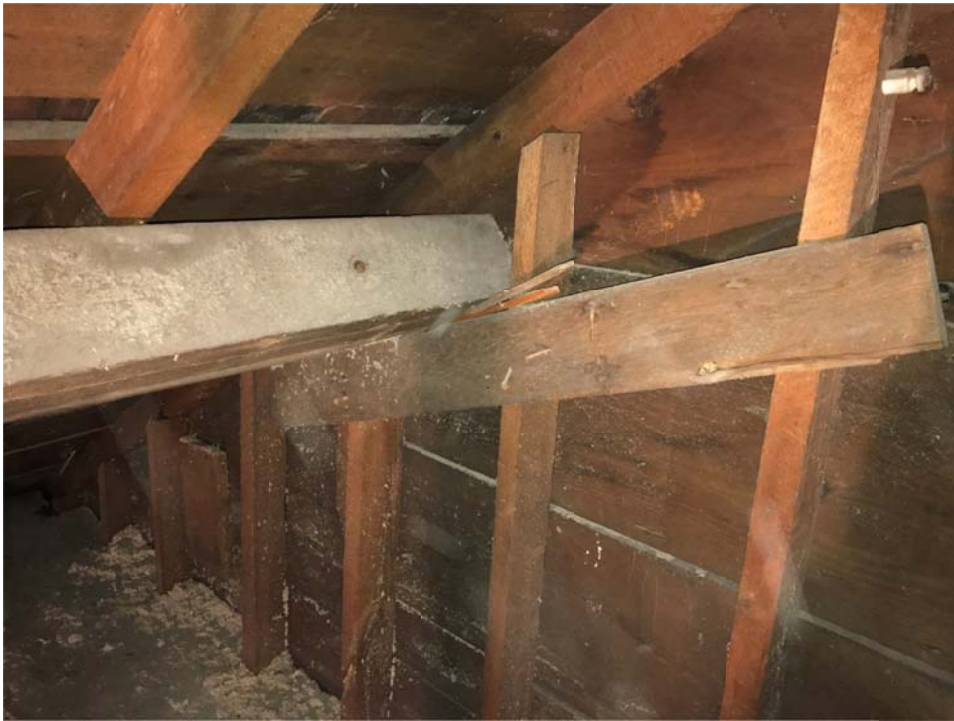
Figure 9—View of beam bearing in attic—replacement or reinforcement recommended.

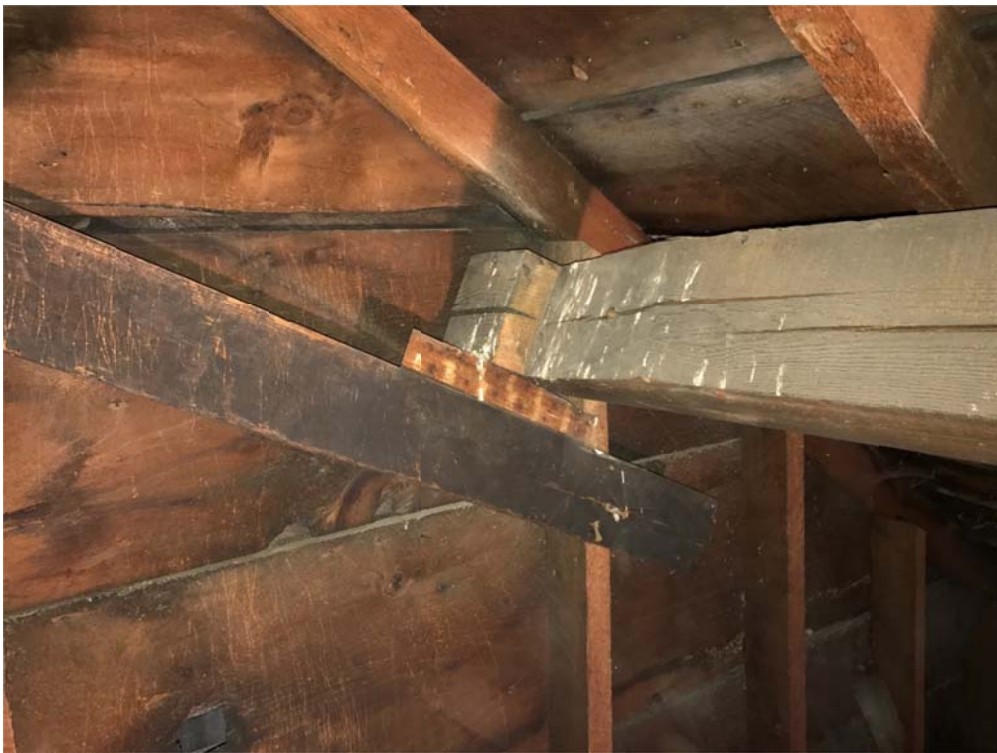
Figure 10—View of beam bearing in attic—replacement or reinforcement recommended.

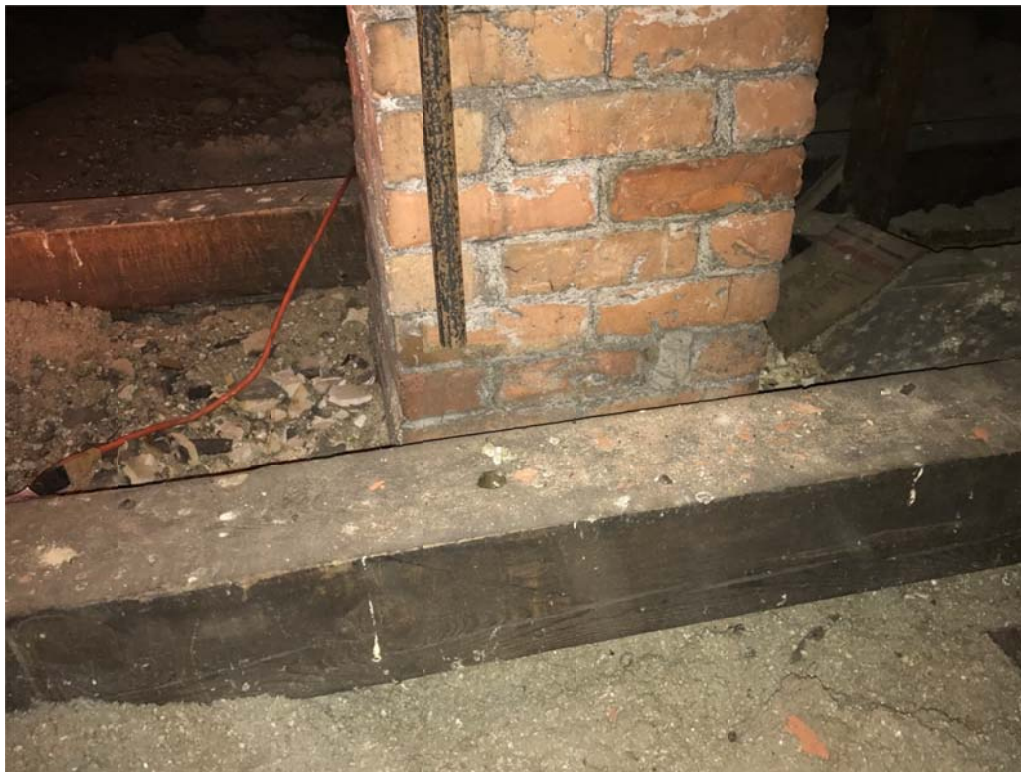
Figure 11—View of structural connector dislodged in attic.

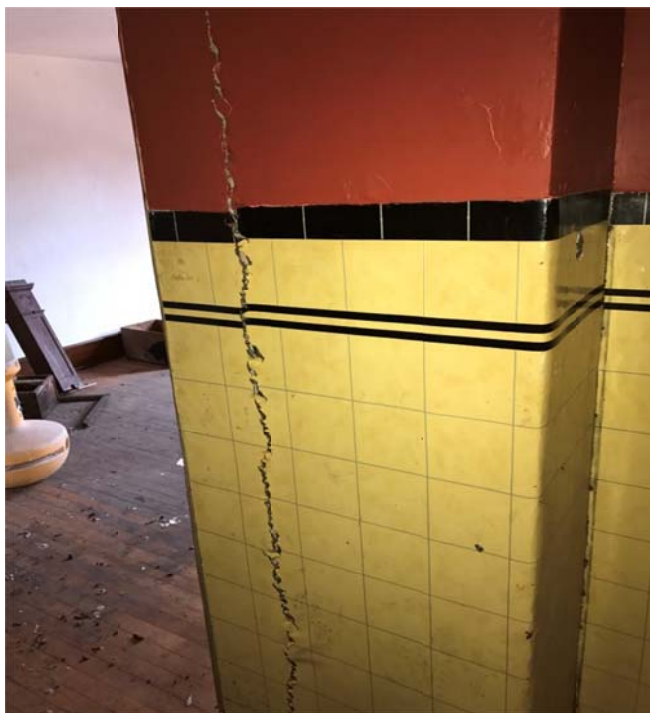
Figure 12—View of crack at chimney on second floor.

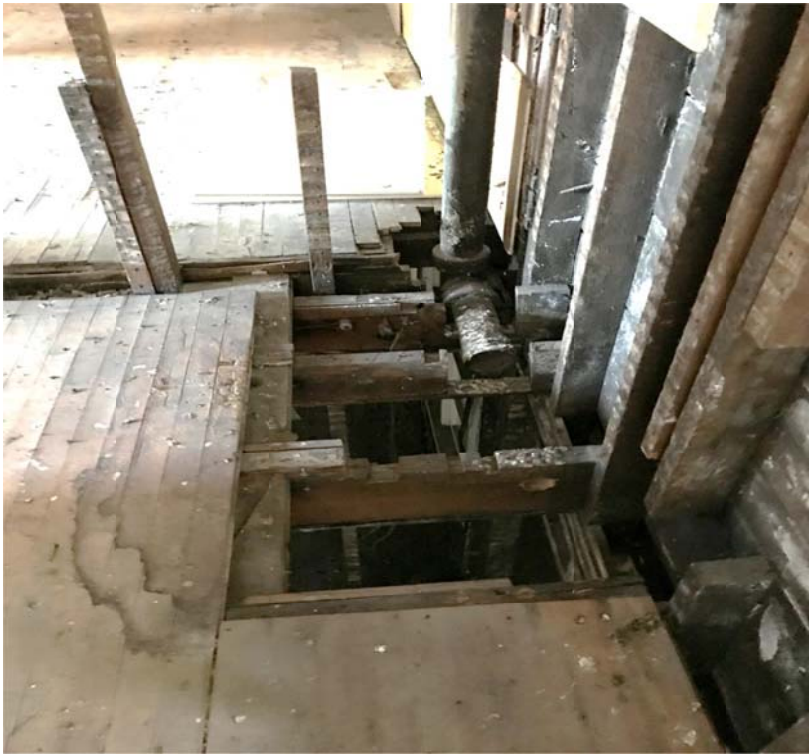
Figure 13—View of notched floor joists at second level.

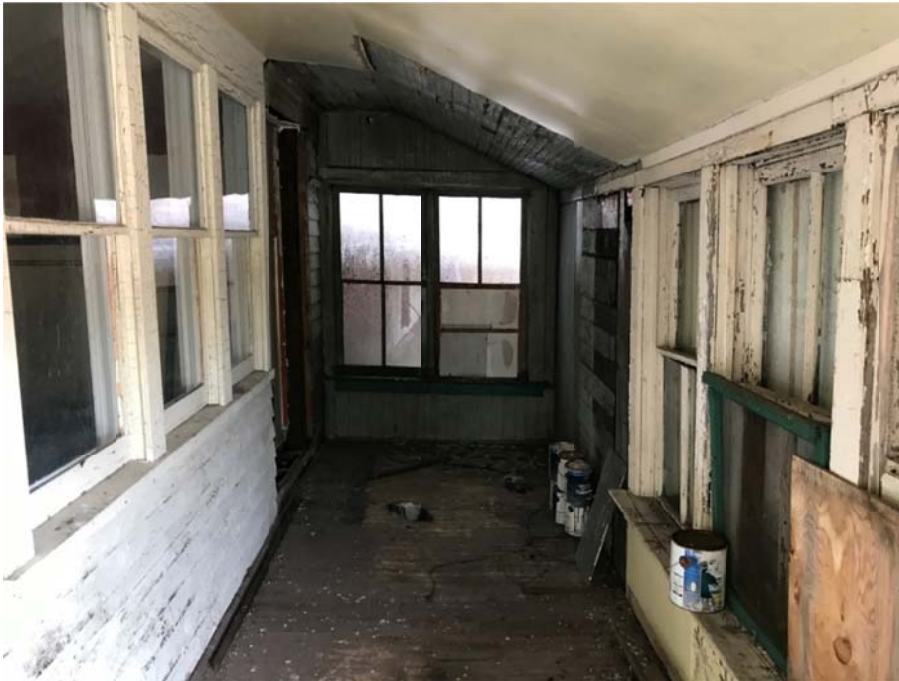
Figure 14—View of East end of second floor porch—wet ceiling, buckled floor and pigeon feces.

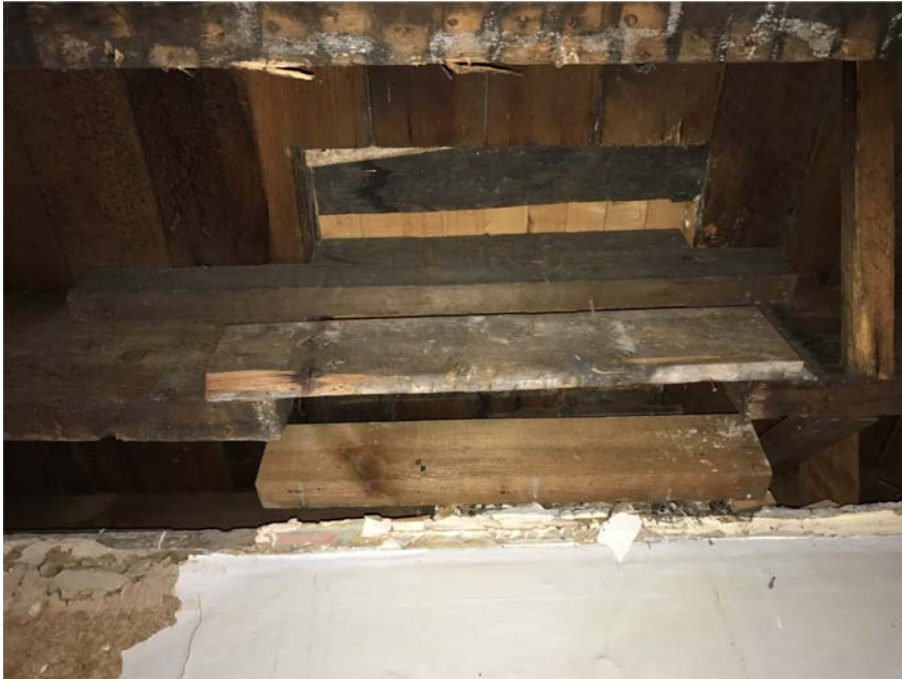
Figure 15—View of notched floor joist.

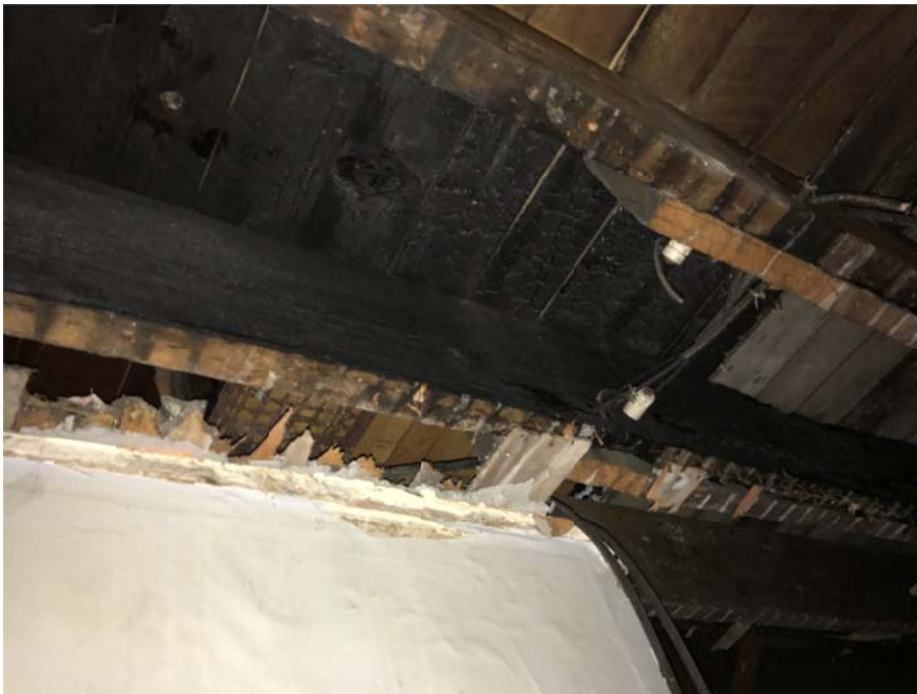
Figure 16—View of charred floor joists and floor boards.

6. Reinforce/replace first floor and wall framing as required.
7. Reinforce/replace exterior wall of porch area due to rotting framing and siding.
8. Replace charred framing members as required.

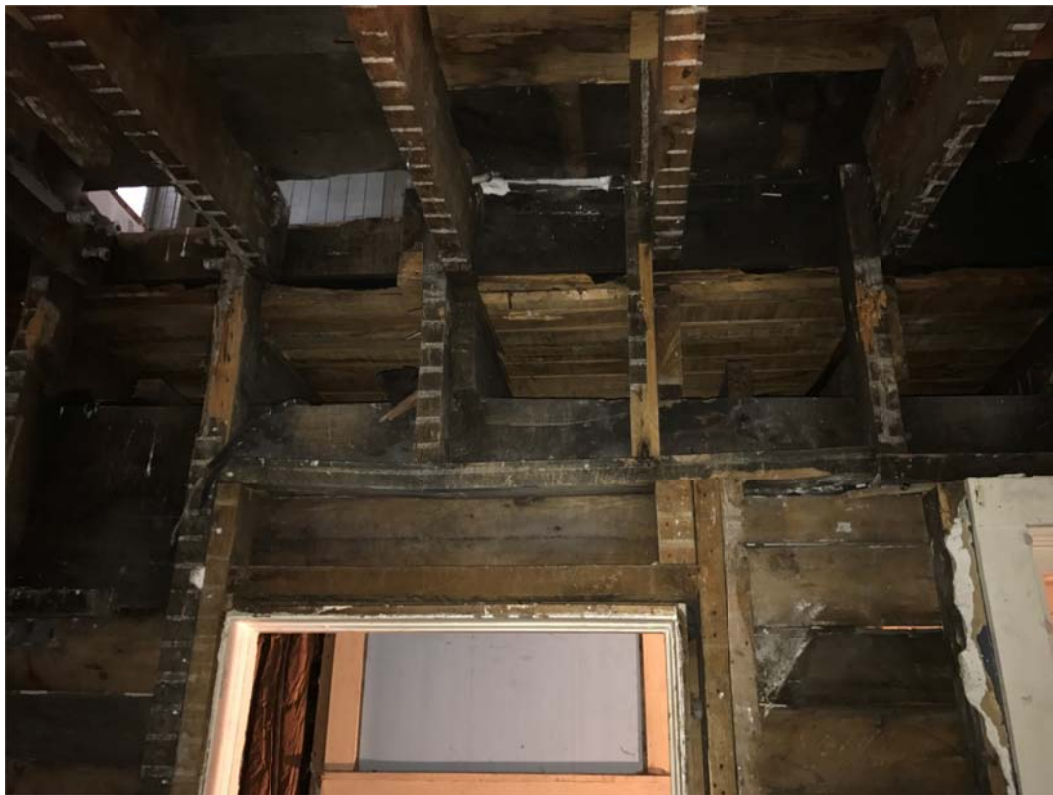
Figure 17—View of sagging header at ground floor.

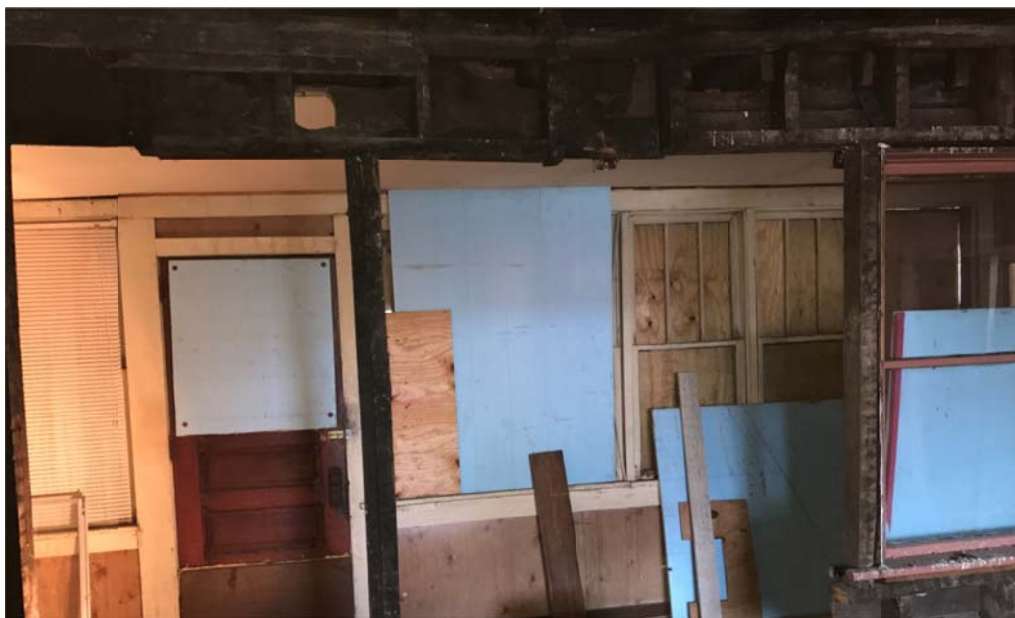
Figure 18—View of sagging header at ground level.

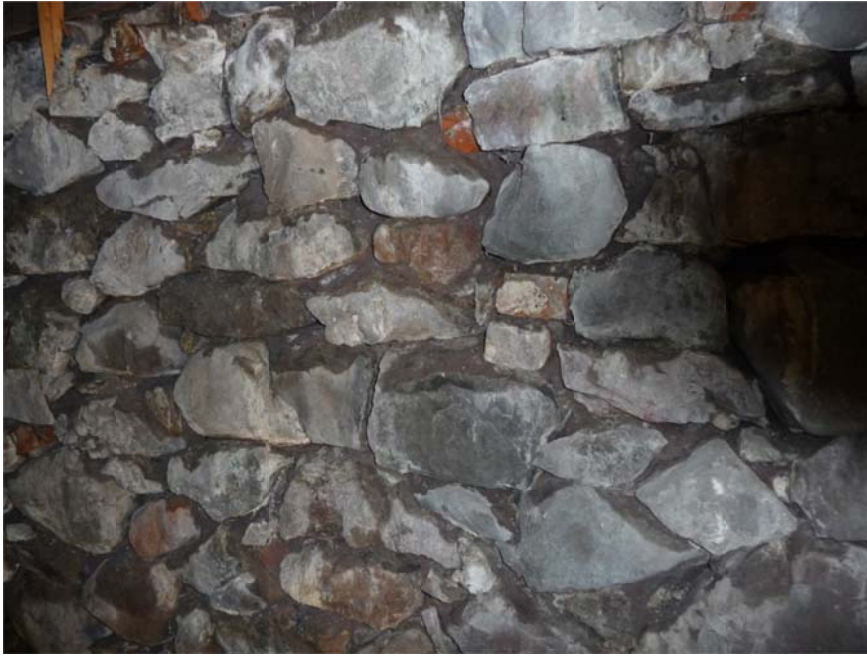
Figure 19—View of rock foundation wall in basement---mortar is deteriorating.

12. Tuck-point masonry areas as needed.

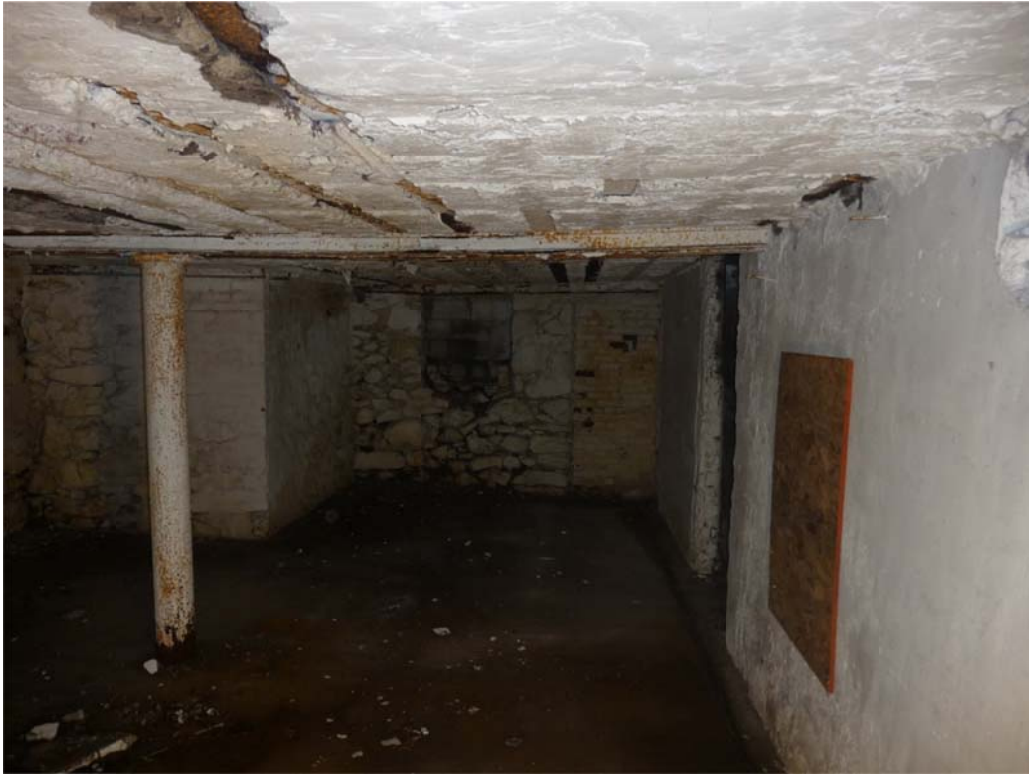
Figure 20—View of concrete/steel of porch area in basement

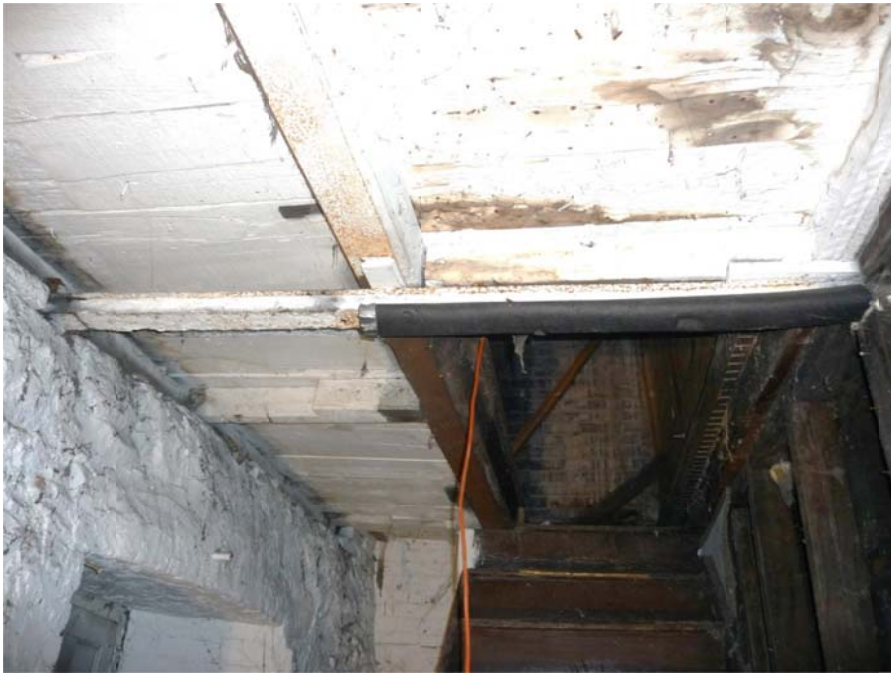
Figure 21—View of steel framing at stairwell to basement—capacity is in question.

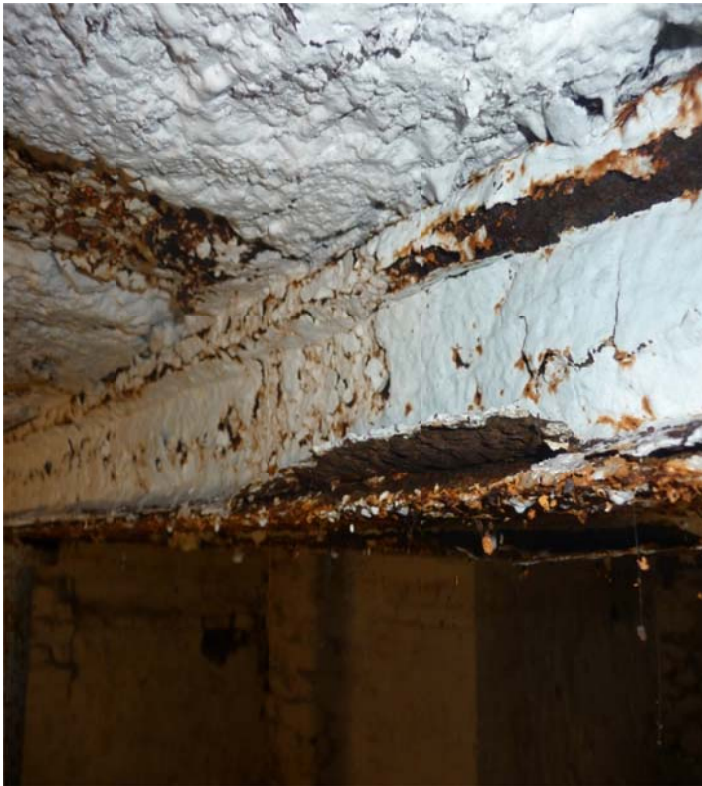
Figure 22—View of corroded steel in roof of porch area in basement.

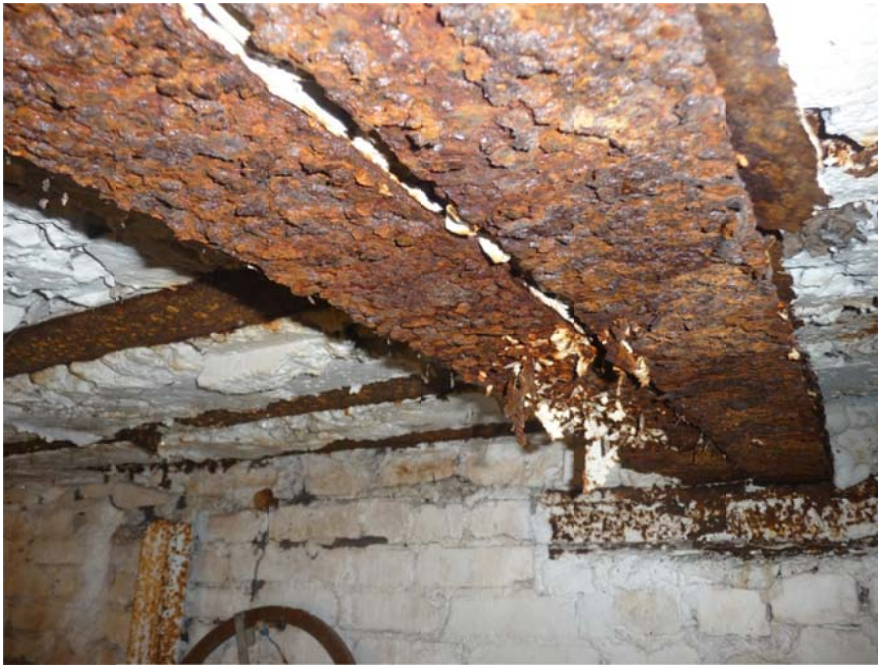
Figure 23—View of corroded steel in roof of porch area in basement.

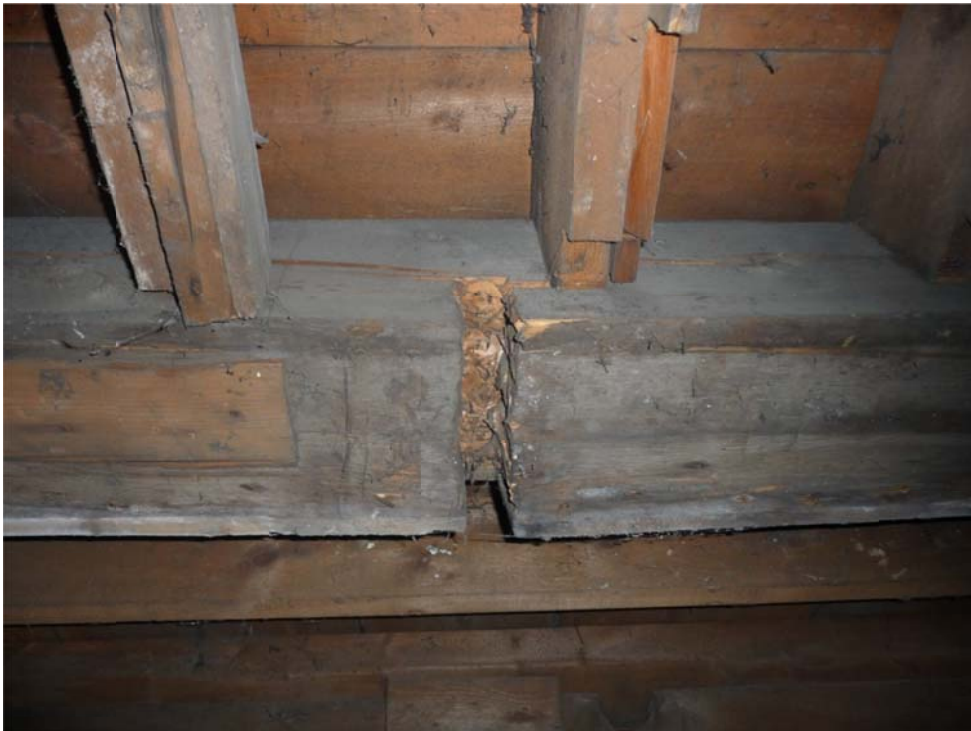
Figure 24—View of notched beam supporting first floor framing.

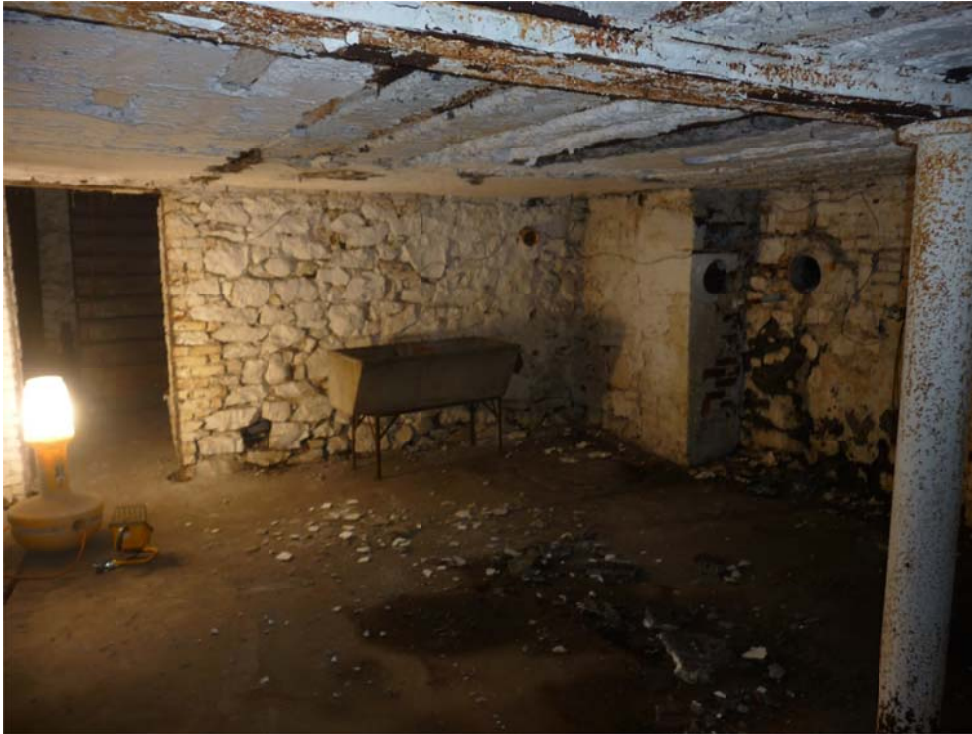
Figure 25—View of ceiling debris from porch area roof in basement.

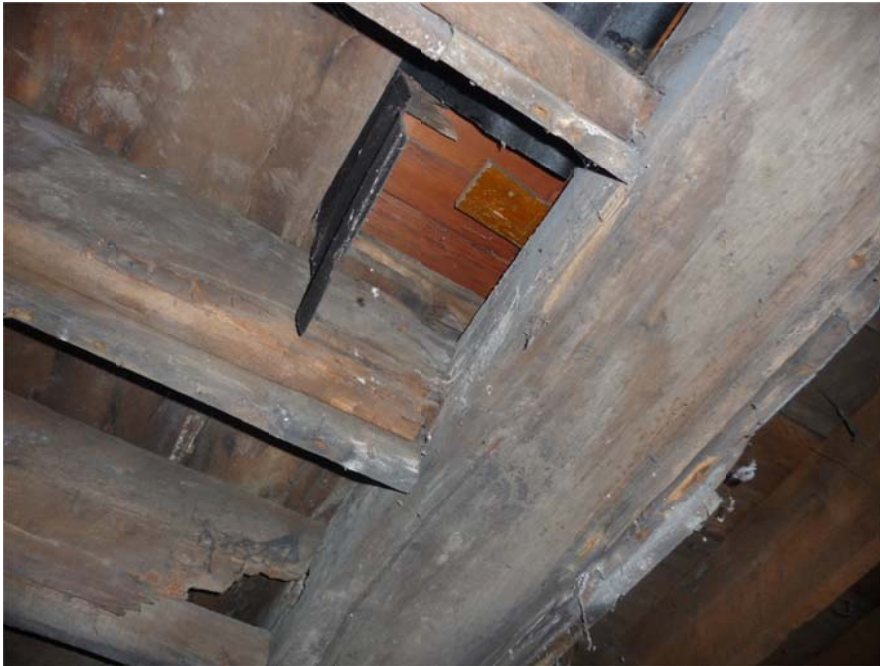
Figure 26—View of bearing of first floor joists is need of reinforcement.

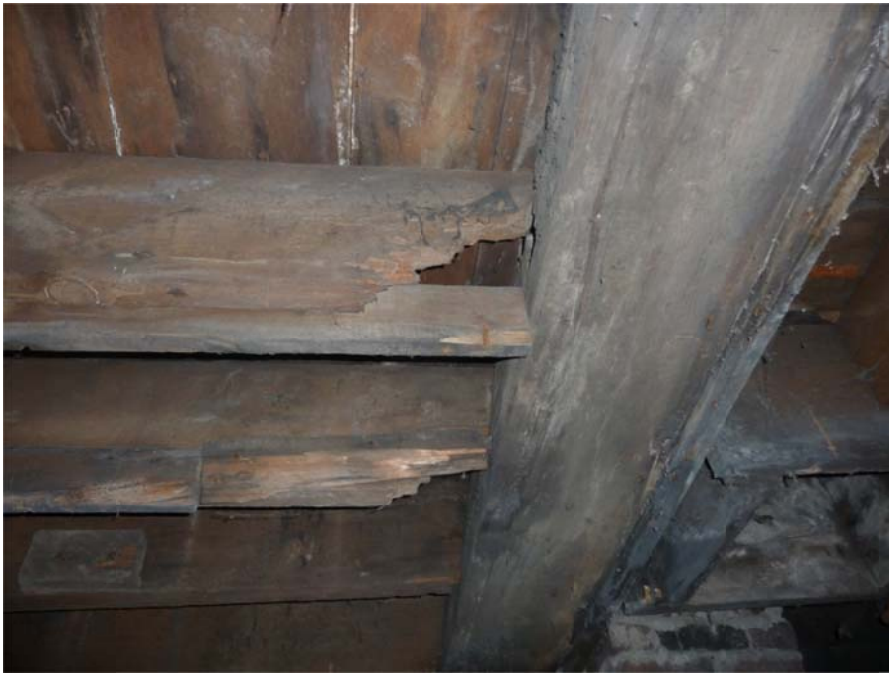
Figure 27—View of bearing condition of first floor joist at beam in need of reinforcement.

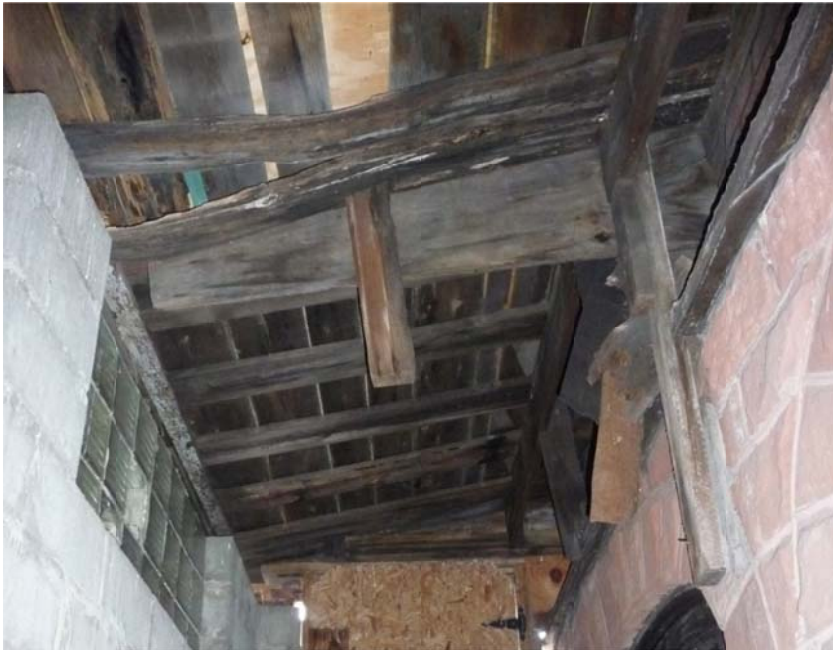
Figure 28—Roof framing at West entrance to basement—capacity in question.

1. Analyze reinforce main roof rafters as required to support anticipated loading.
2. Analyze and reinforce/replace roof members and West entry to basement.

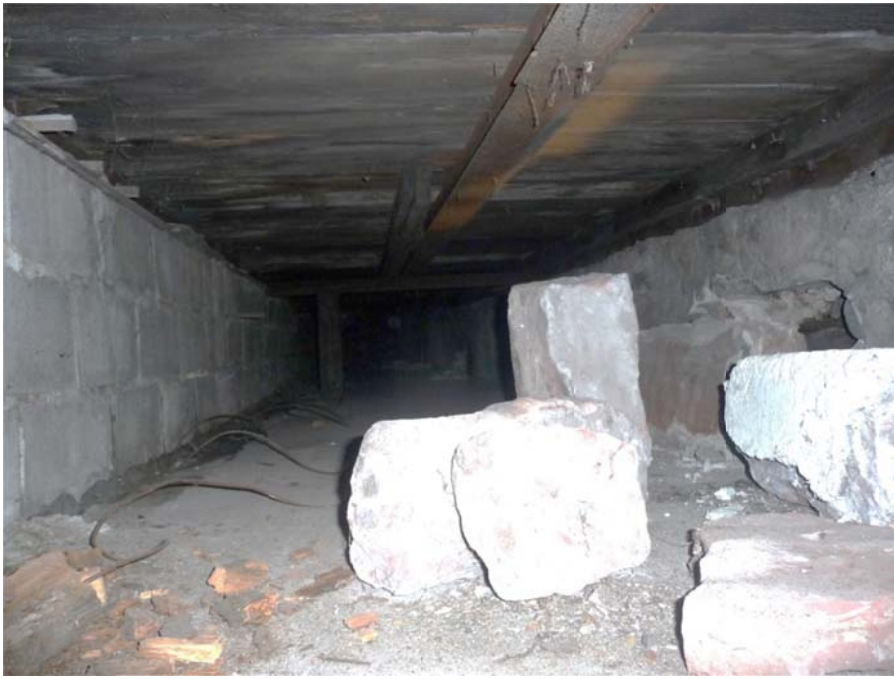
Figure 29—View of area below South porch and above basement—block wall sets on deteriorating concrete.

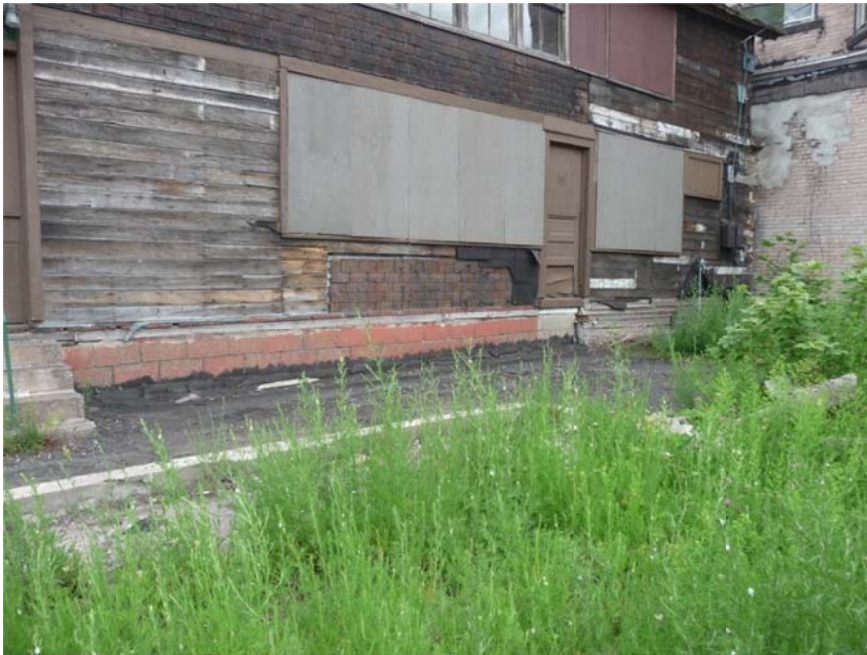
Figure 30—View of South Wall—block wall supporting wall sets on deteriorating concrete slab of basement.

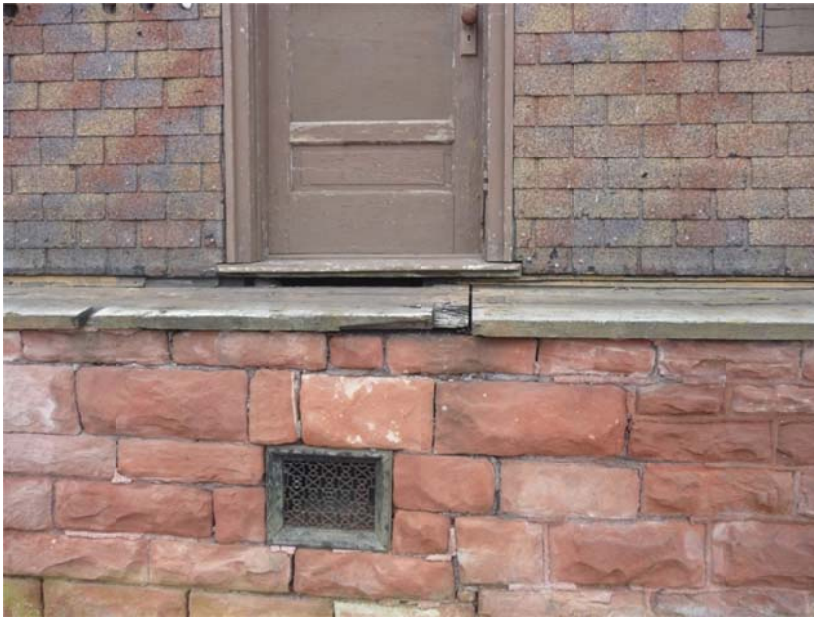
Figure 31—View of North side sandstone—tuck-pointing needed as well as top sealing.

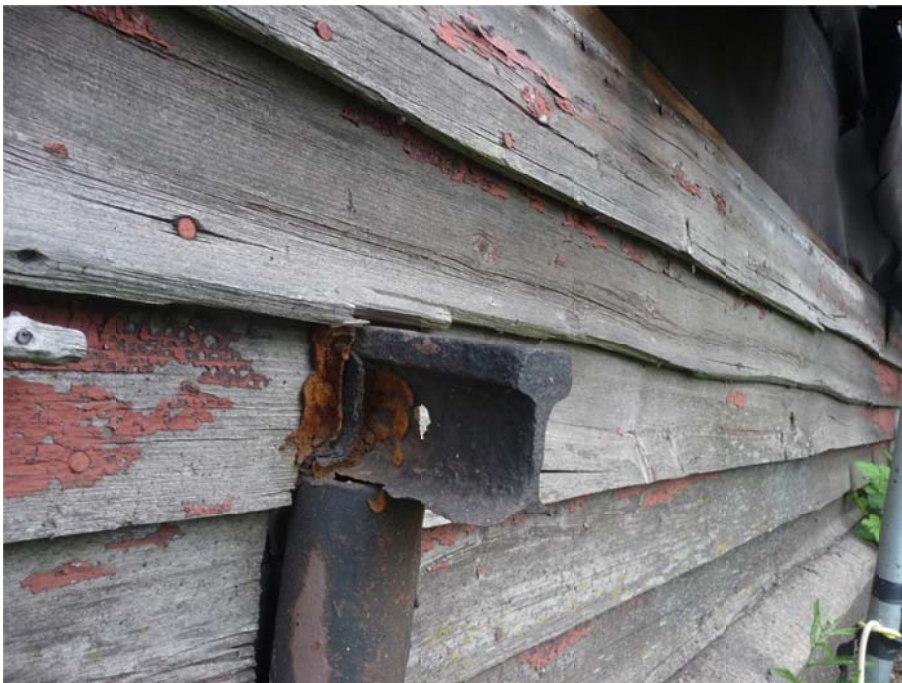
Figure 32—Framing protruding from South wall—not corrosion of bottom flange/web.

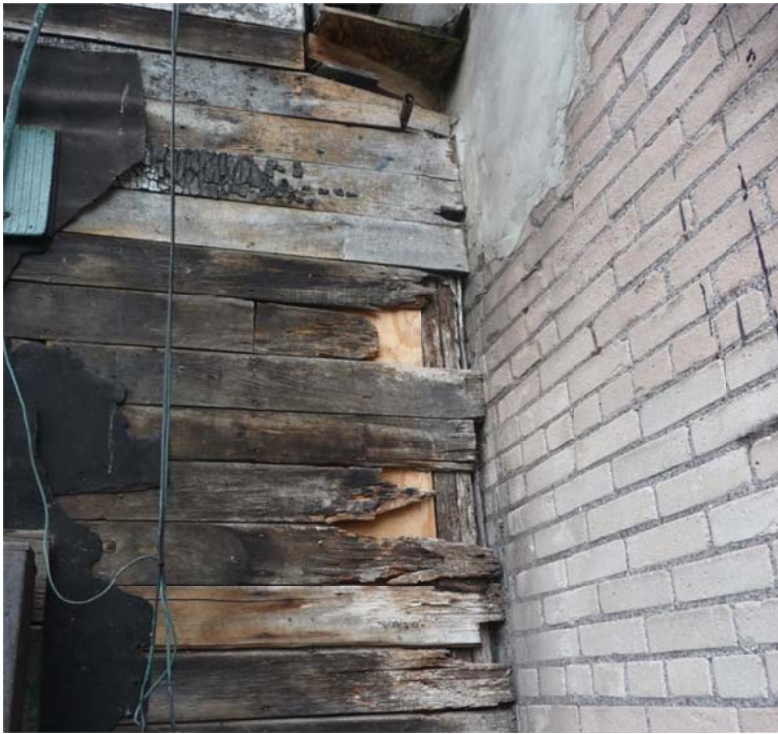
Figure 33—Rotted wall boards of South wall.

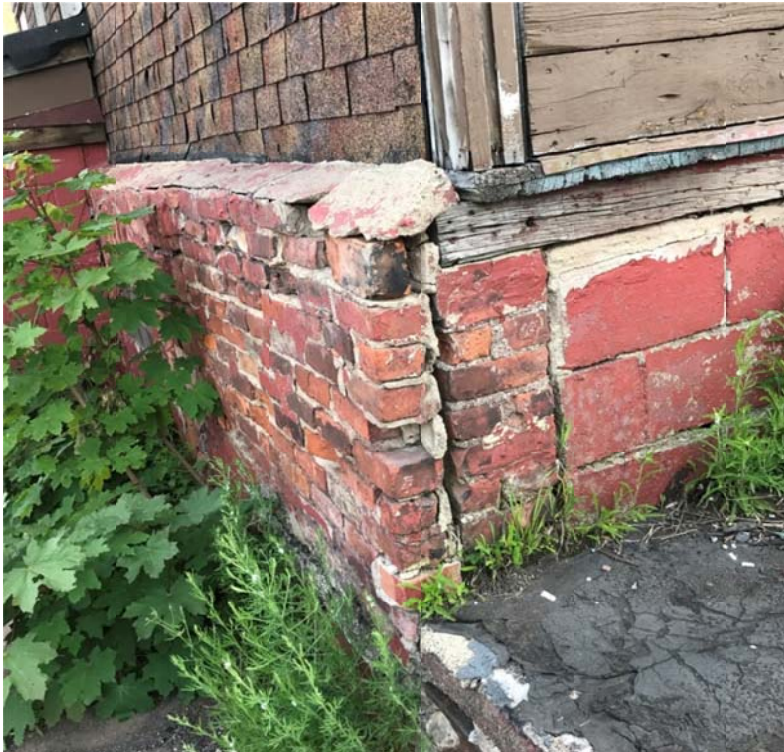
Figure 34—Brick repair needed at SW corner of structure.

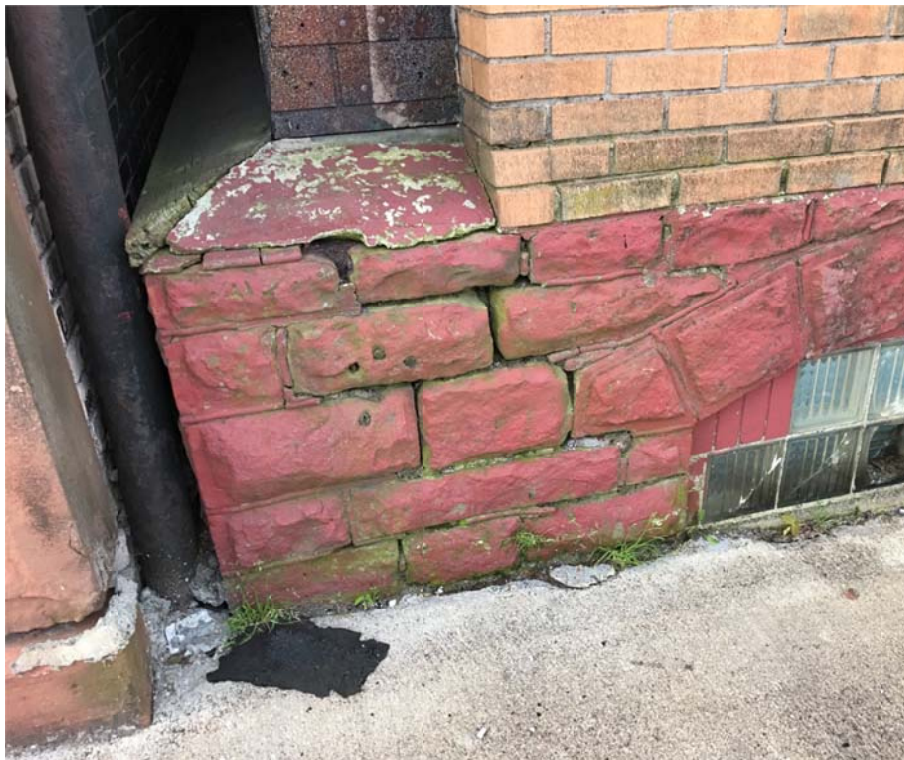
Figure 35—Tuck-pointing needed at NE corner.
