# Village of Calumet 512 Portland Street—Curto Building Structural Assessment

October 18, 2017

RE: 512 Portland Street  
Structural Assessment Report

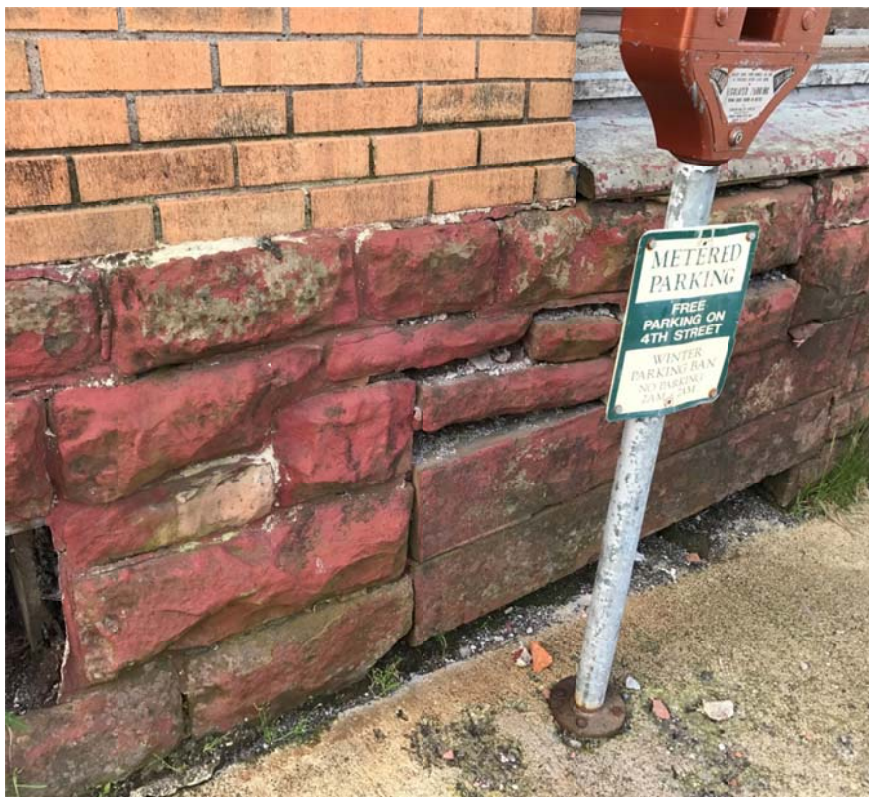
Figure 36—Tuck-pointing/infill needed at North wall sandstone.

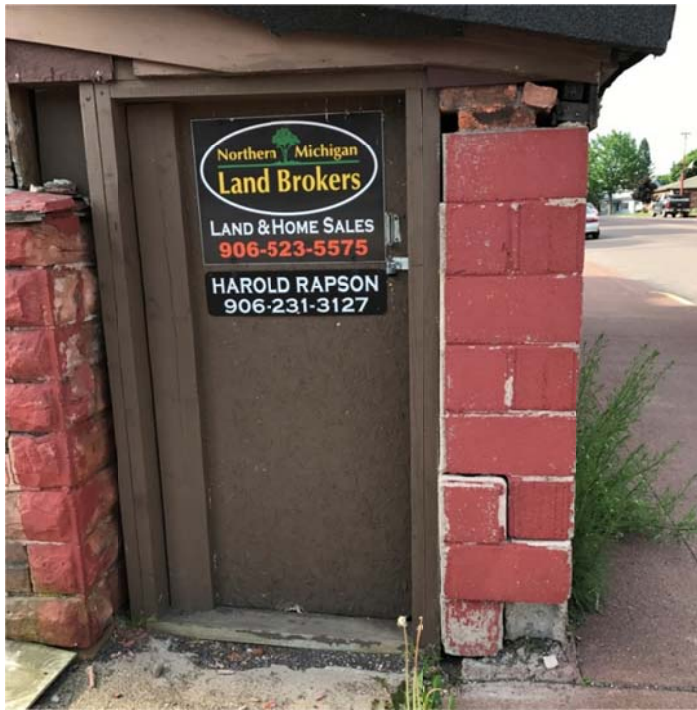
Figure 37—Block repair needed at West entrance to basement.

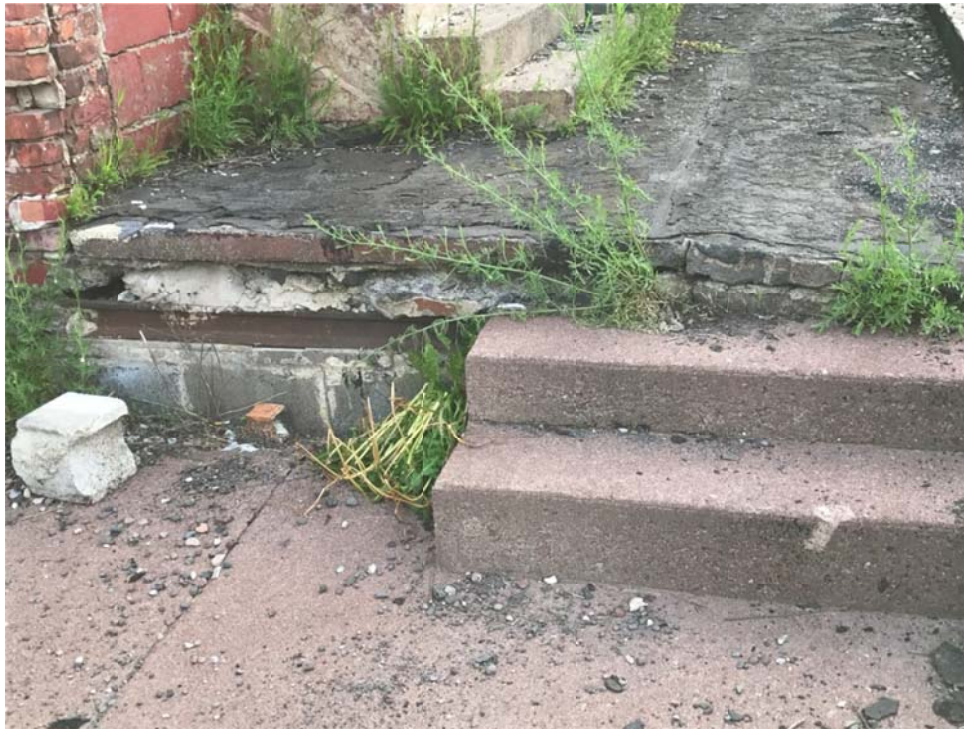
Figure 38—Framing/concrete deterioration of slab over basement area.

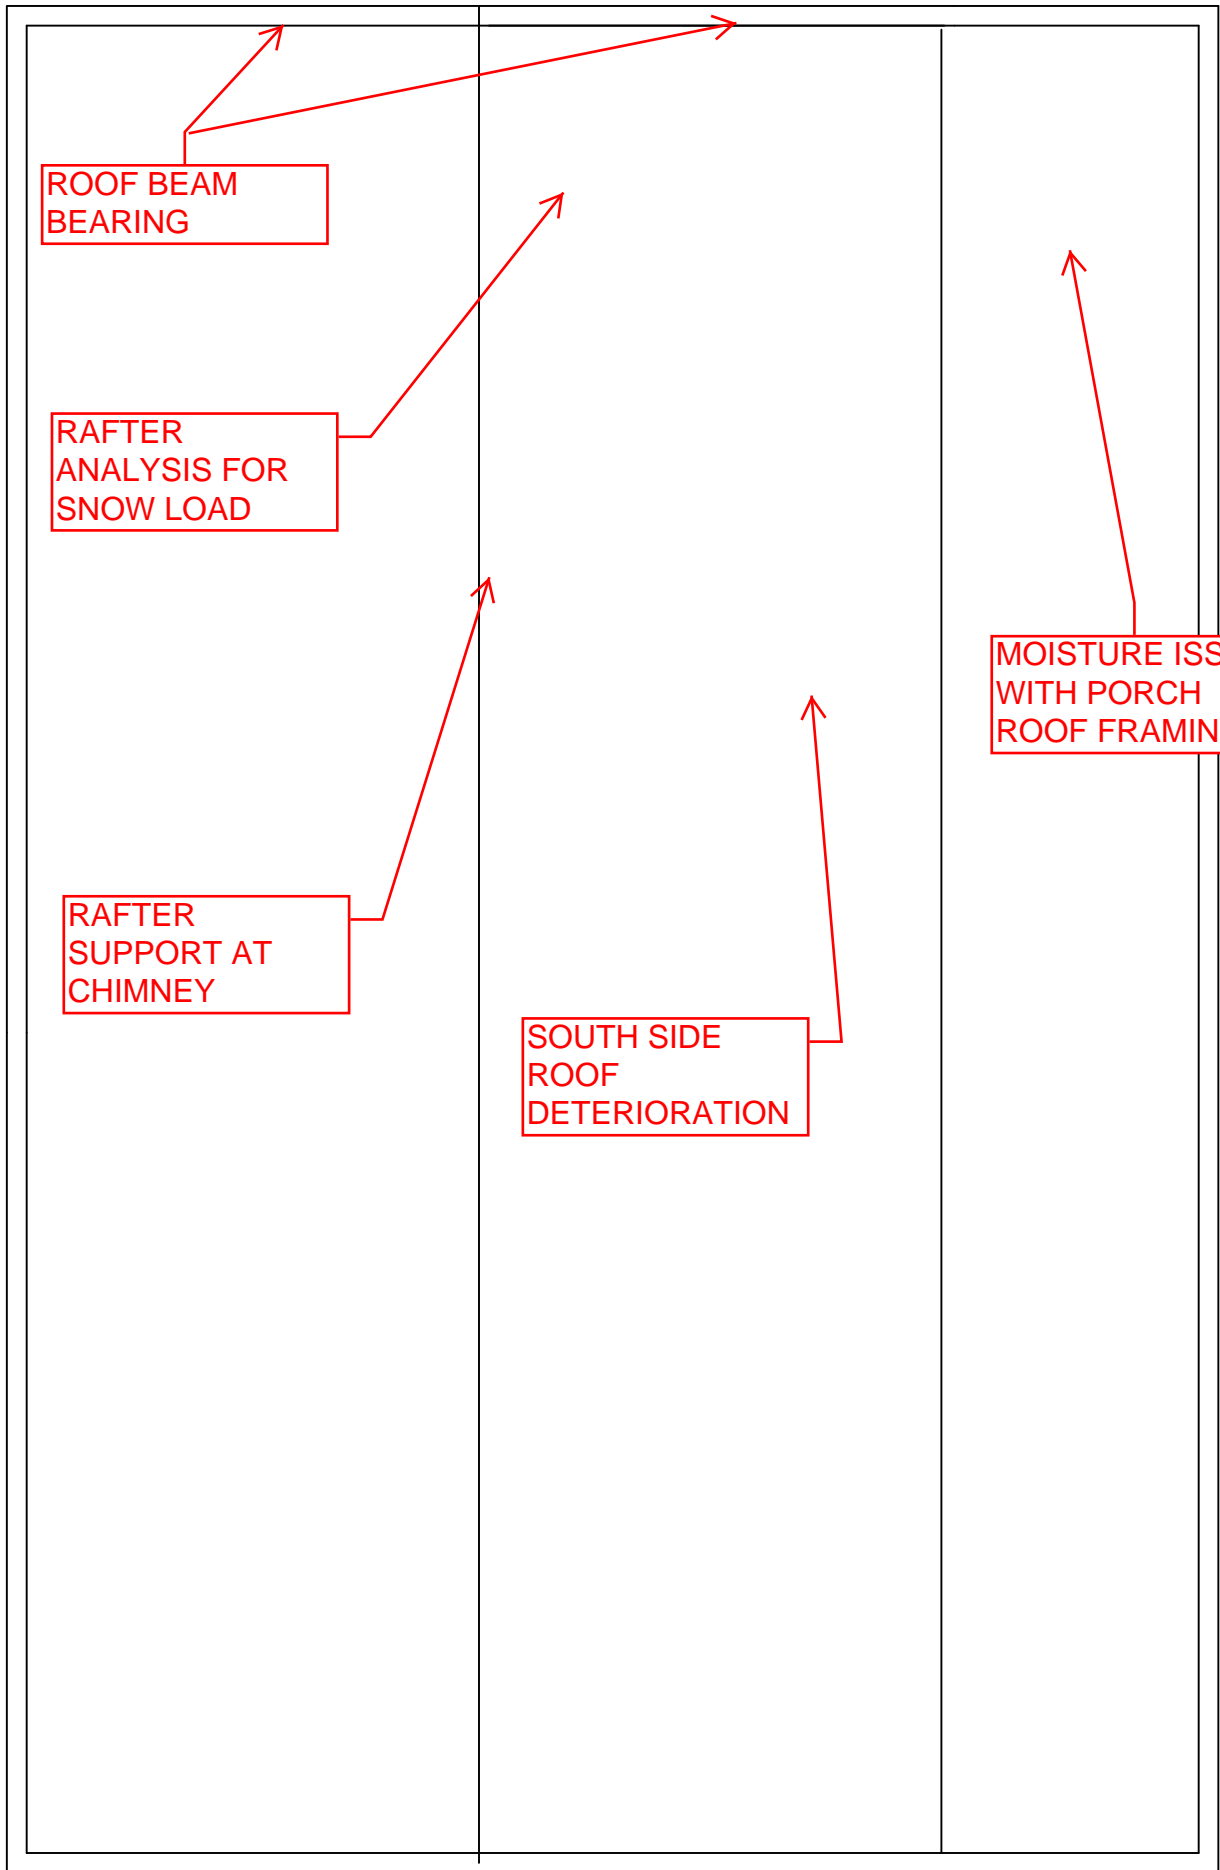
ROOF PLAN

ROOF BEAM  
BEARING

RAFTER  
ANALYSIS FOR  
SNOW LOAD

RAFTER  
SUPPORT AT  
CHIMNEY

SOUTH SIDE  
ROOF  
DETERIORATION

MOISTURE ISSUE  
WITH PORCH  
ROOF FRAMING

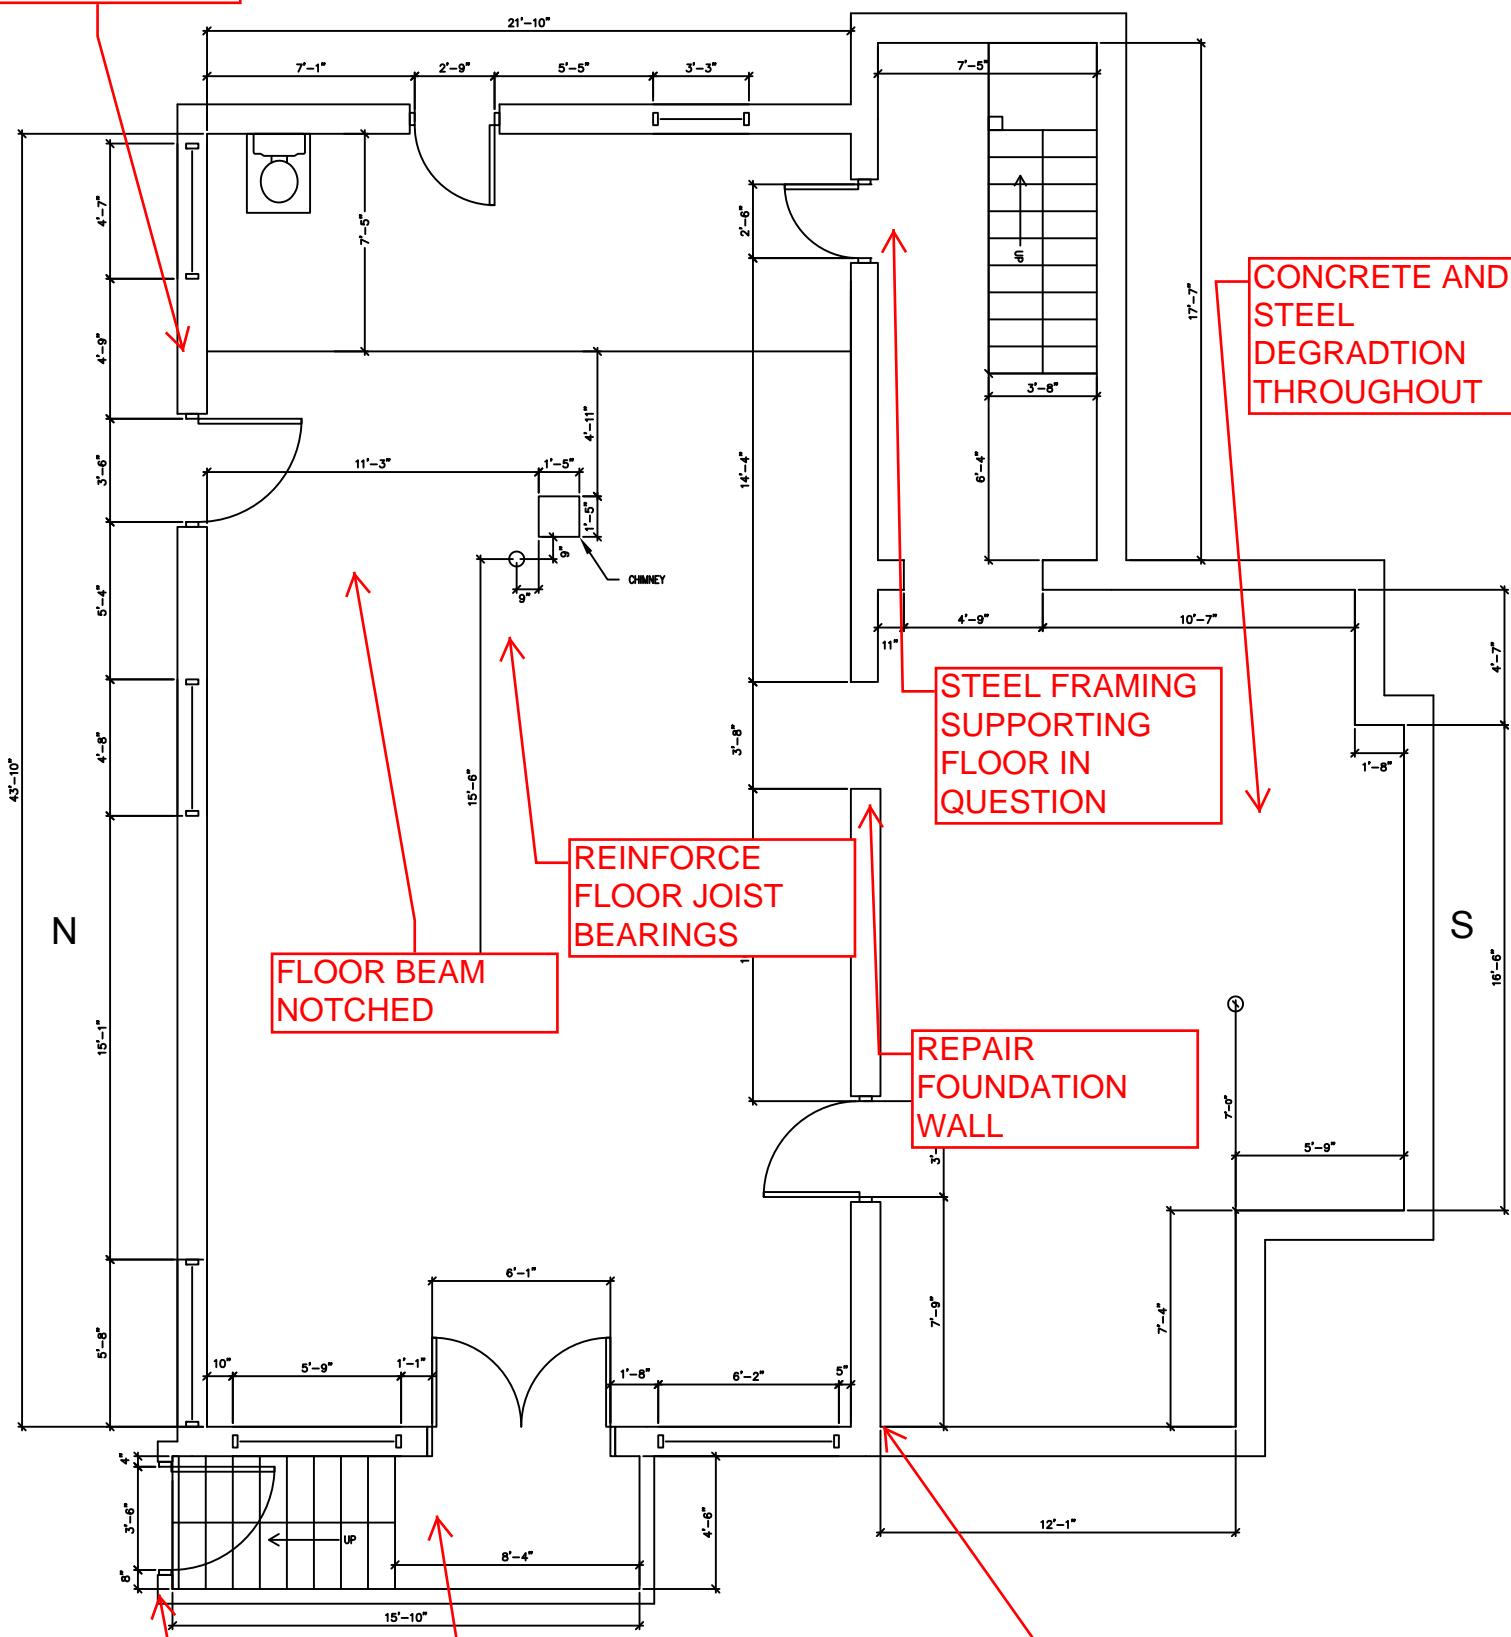
BASEMENT PLAN

SANDSTONE  
TUCKPOINT/  
REPLACEMENT

CONCRETE AND  
STEEL  
DEGRADATION  
THROUGHOUT

STEEL FRAMING  
SUPPORTING  
FLOOR IN  
QUESTION

REINFORCE  
FLOOR JOIST  
BEARINGS

FLOOR BEAM  
NOTCHED

REPAIR  
FOUNDATION  
WALL

BRICK TIE AND  
REPAIR

BLOCK  
TUCKPOINING/  
REPAIR NEEDED

REVIEW CAPACITY OF  
ROOF FRAMING
