# Village of Calumet 427 5th Street--Agnitz Block Structural Assessment

RE: 427 5<sup>th</sup> Street  
Structural Assessment Report

The inspection of 427 5th Street in the Village of Calumet has been completed. The initial drone inspection was conducted on June 7<sup>th</sup>, 2017 which included the roof and front façade. On August 3<sup>rd</sup> a second inspection was conducted which included the attic space, second floor, first floor, basement and exterior.

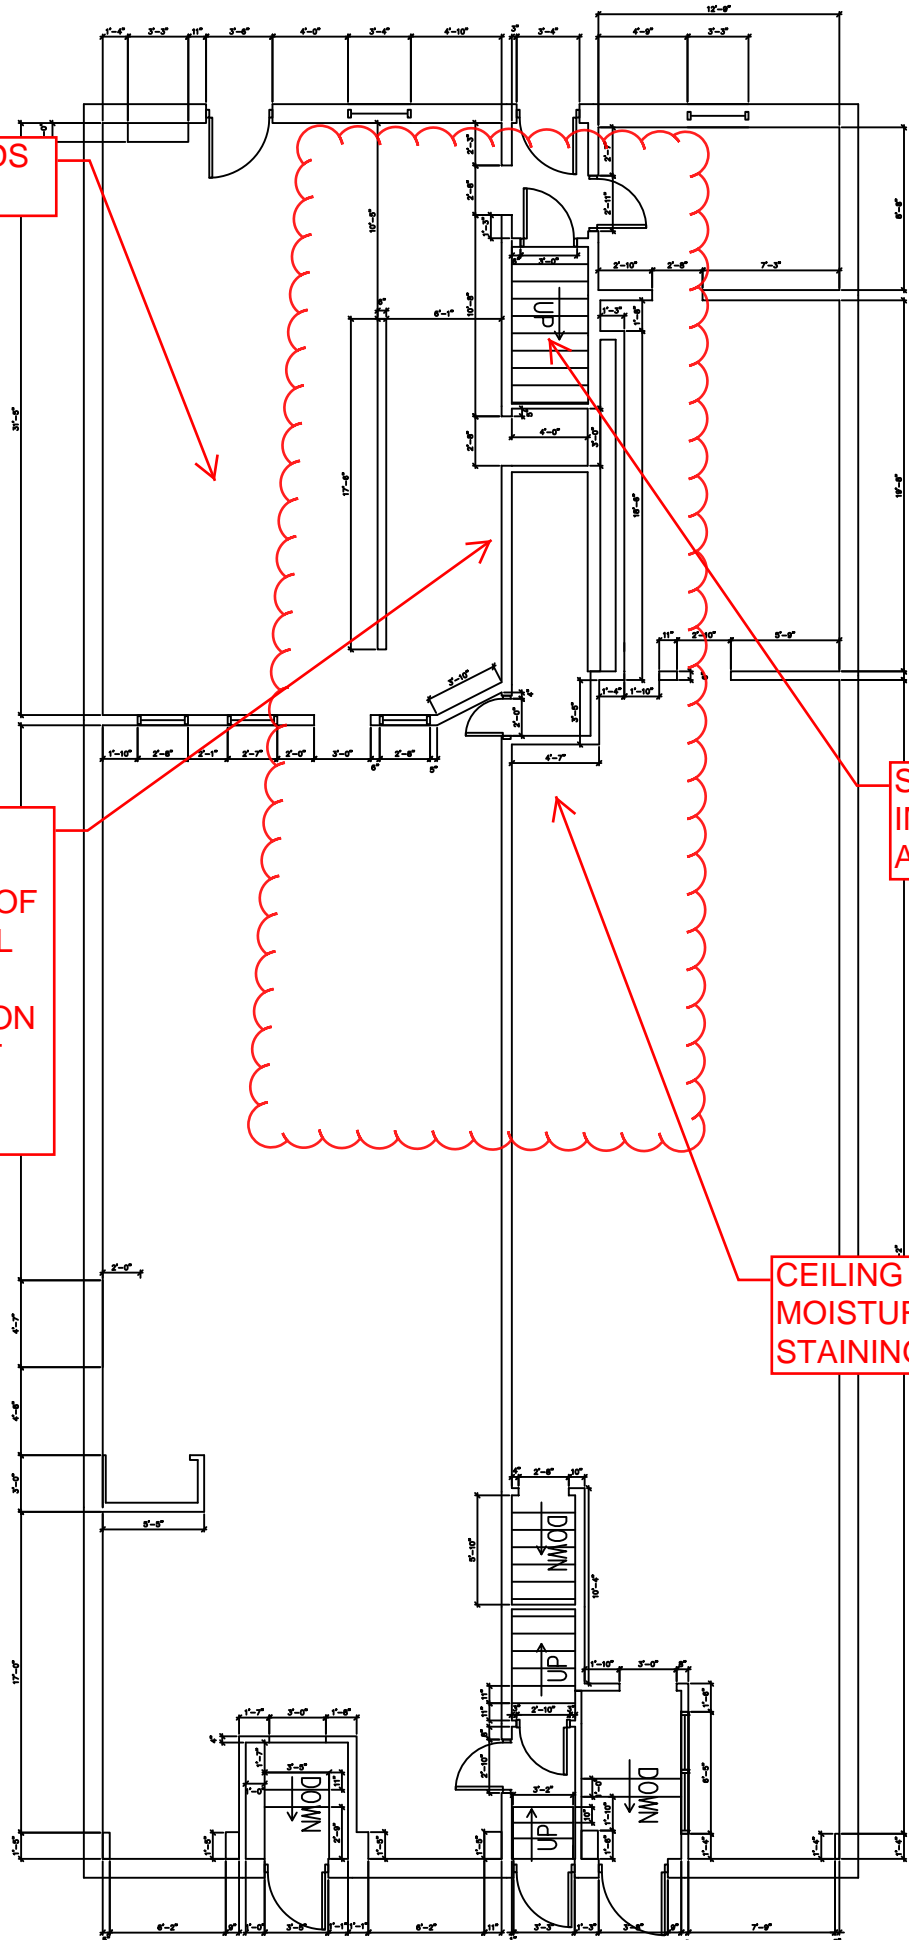
FIRST FLOOR PLAN

AREAS  
BARRICADED.  
SETTLEMENT OF  
BEARING WALL  
MOISTURE  
DETERIORATION  
THROUGHOUT

STAIRWELL  
IMPASSABLE  
AND UNSOUND

CEILING  
MOISTURE  
STAINING
