6 PRESERVATION BRIEFS

Dangers of Abrasive Cleaning to Historic Buildings

U.S. Department of the Interior
National Park Service
Cultural Resources
Heritage Preservation Services

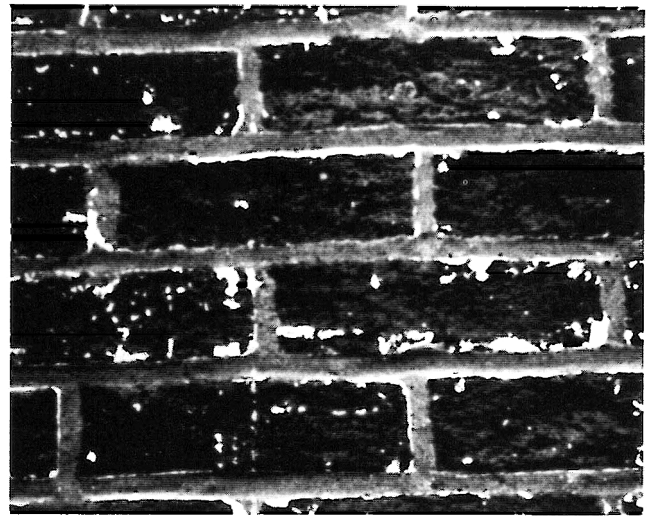
Abrading the Surface without Removing the Paint. *Even though the entire outer surface layer of the brick has been sandblasted off, spots of paint still cling to the masonry. Sandblasting or other similarly abrasive methods are not always a successful means of removing paint.*

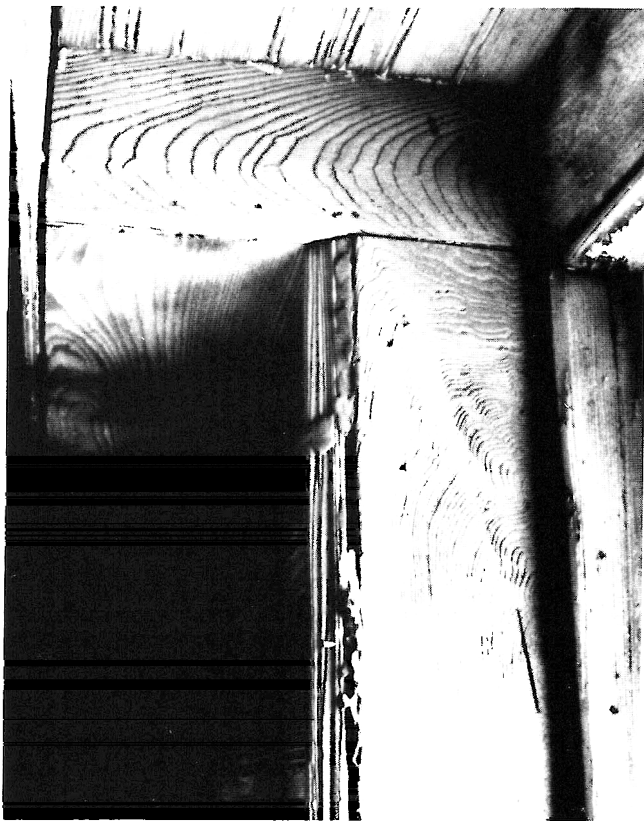
Abrasive Cleaning of Wood. This wooden windowsill, molding and paneling have been sandblasted to remove layers of paint in the rehabilitation of this commercial building. Not only is some paint still embedded in cracks and crevices of the woodwork, but more importantly, grit blasting has actually eroded the summer wood, in effect raising the grain, and resulting in a rough surface.

Wood: Most types of wood used for buildings are soft, fibrous and porous, and are particularly susceptible to damage by abrasive cleaning. Because the summer wood between the lines of the grain is softer than the grain itself, it will be worn away by abrasive blasting or power tools, leaving an uneven surface with the grain raised and often frayed or "fuzzy." Once this has occurred, it is almost impossible to achieve a smooth surface again except by extensive hand sanding, which is expensive and will quickly negate any costs saved earlier by sandblasting. Such harsh cleaning treatment also obliterates historic tool marks, fine carving and detailing, which precludes its use on any interior or exterior woodwork which has been hand planed, milled or carved.

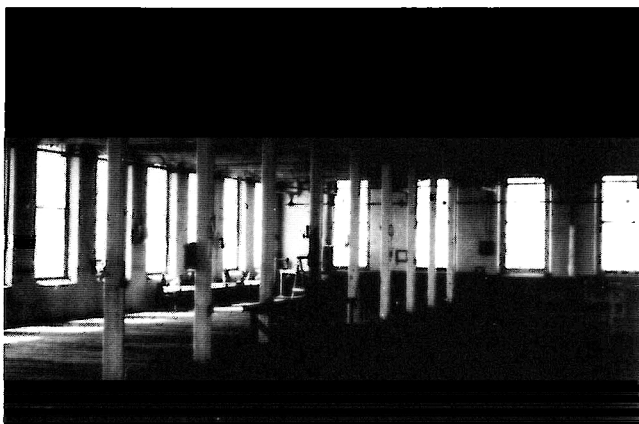
Permissible Abrasive Cleaning. In accordance with the Secretary of the Interior's Guidelines for Rehabilitation Projects, it may be acceptable to use abrasive techniques to clean an industrial interior space such as that illustrated here, because the masonry surfaces do not have significant design, detailing, tooling or finish, and the wooden architectural features are not finished, molded, beaded or worked by hand.

Interior spaces of factories or warehouse structures in which the masonry or plaster surfaces do not have significant design detailing, tooling or finish and in which wooden architectural features are not finished, molded, beaded or worked by hand, may be cleaned abrasively in order to remove layers of paint and industrial discolorations such as smoke, soot, etc. It is expected after such treatment that brick surfaces will be rough and pitted, and wood will be somewhat frayed or "fuzzy"

with raised wood grain. These nonsignificant surfaces will be damaged and have a roughened texture, but because they are interior elements, they will not be subject to further deterioration caused by weathering.

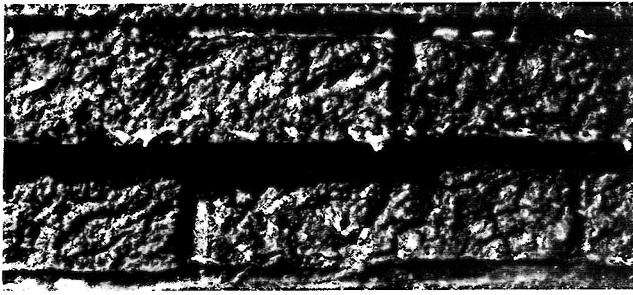
Hazards of Sandblasting and Surface Coating. In order to "protect" this heavily sandblasted brick, a clear surface coating or sealer was applied. Because the air temperature was too cold at the time of application, the sealer failed to dry properly, dripping in places, and giving the brick surface a cloudy appearance.

sealers reduce the transpiration of moisture allowing salts to crystallize as subflorescence that eventually spalls the brick. If a brick surface has been so extensively damaged by abrasive cleaning and weathering that spalling has already begun, it may be necessary to cover the walls with stucco, if it will adhere.
